# JONGENSFONTEIN PROMENADE

## Motivation and Preliminary Development Concept – DRAFT REPORT

This report provides an assessment of the vulnerability and risk associated with the Strand Street shoreline interface from a coastal engineering perspective, and makes recommendations of possible structural interventions to address flooding and associated risks.

This report was written by coastal engineering specialist Dr André van Tonder, B Eng, Hons B Eng, PhD (Civil Engineering), Pr Eng, for use by the Jongensfontein Ratepayers Association (JRA).

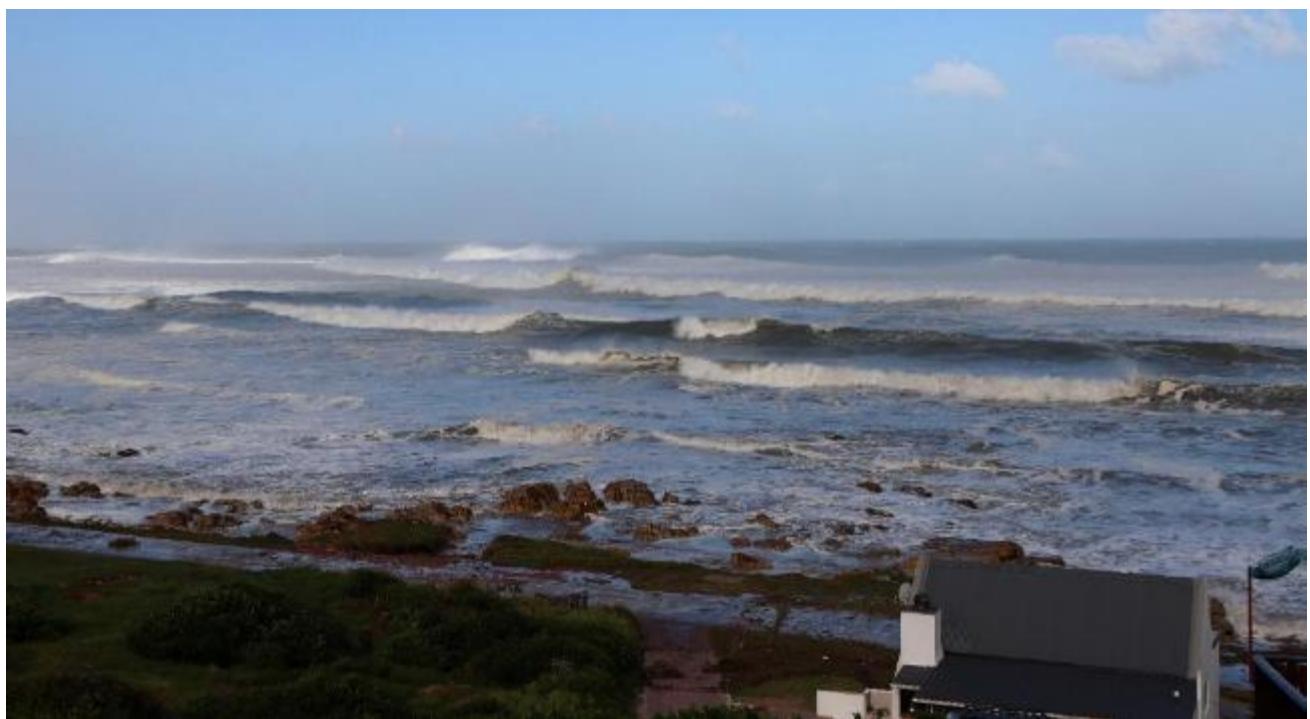
Figure 7 Strand Street flooding around Ch 300 with Oom Soon se Huis in right front at 15:29 16 Sept 2023

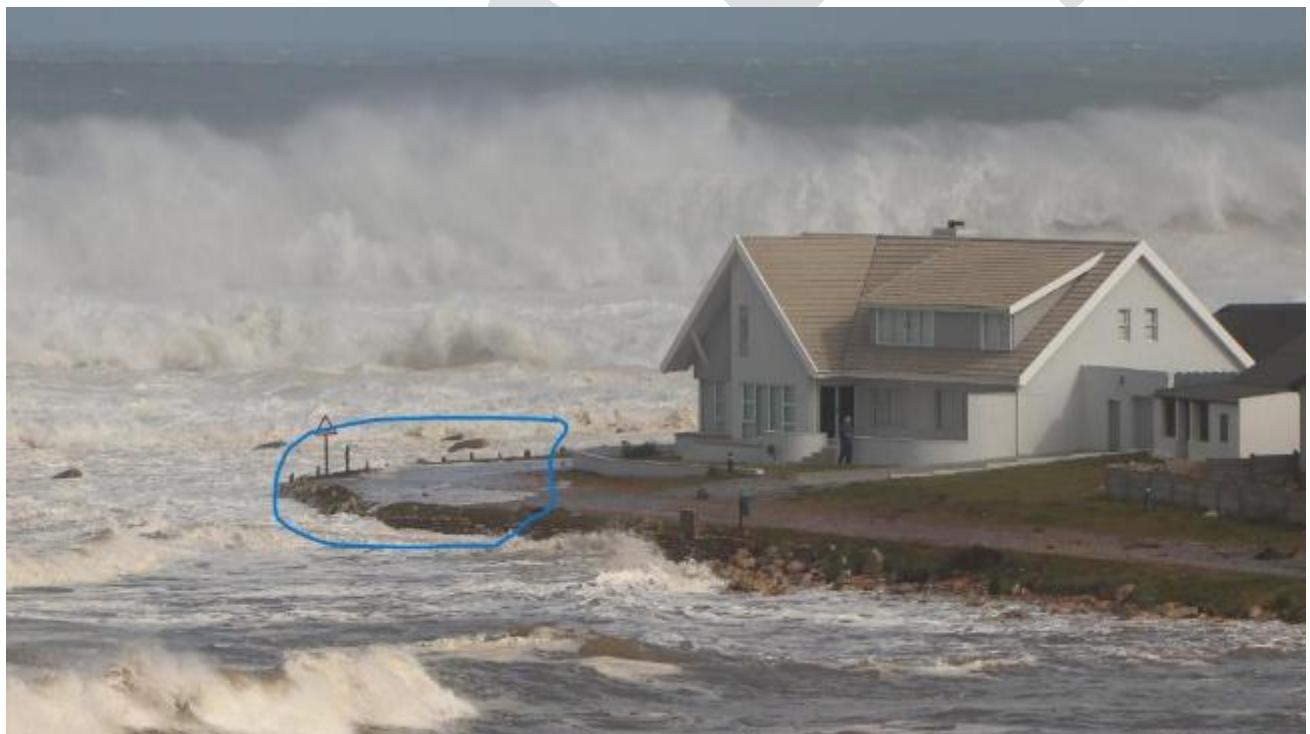
Figure 9 Strand Street flooding around Ch 750 at 15:31 on 16 Sept 2023

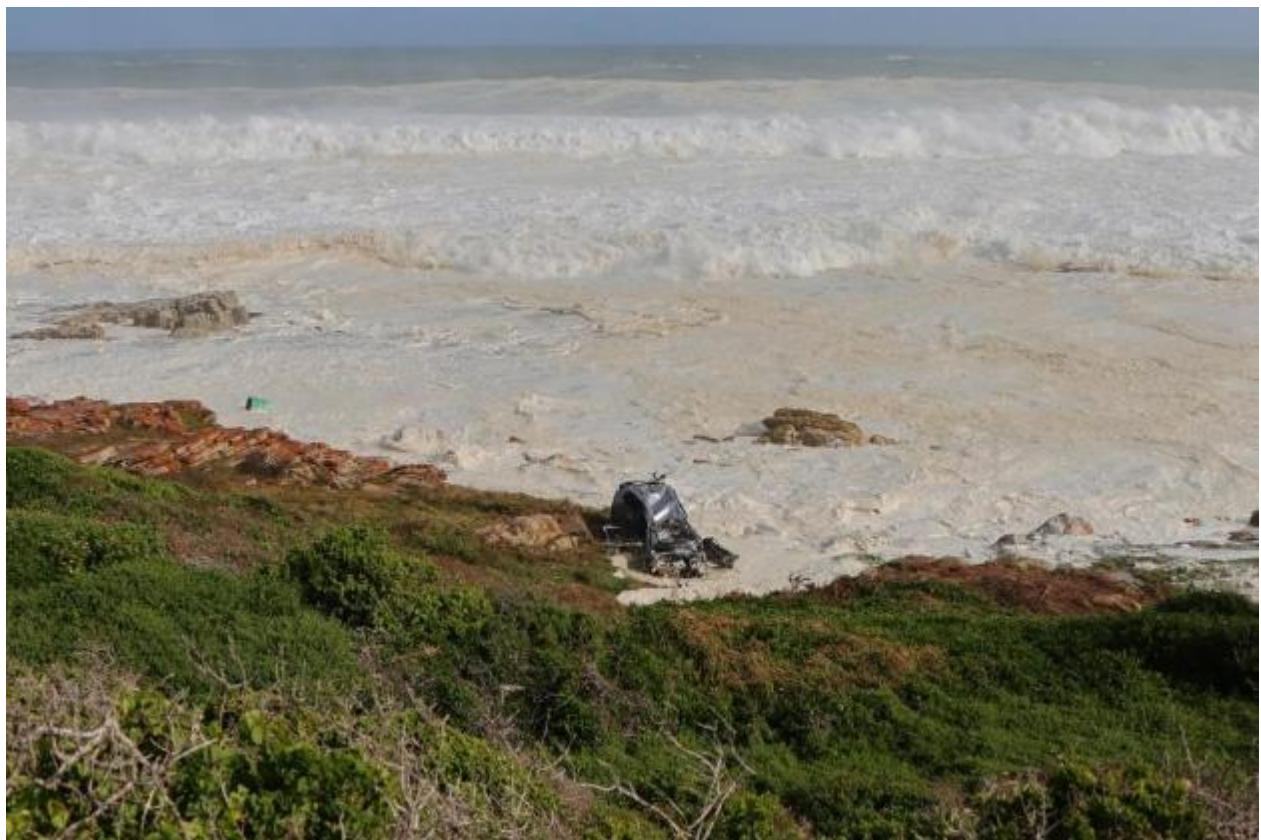
Figure 10 Vehicle wrecked below Main Road at 15:39 on 16 Sept 2023

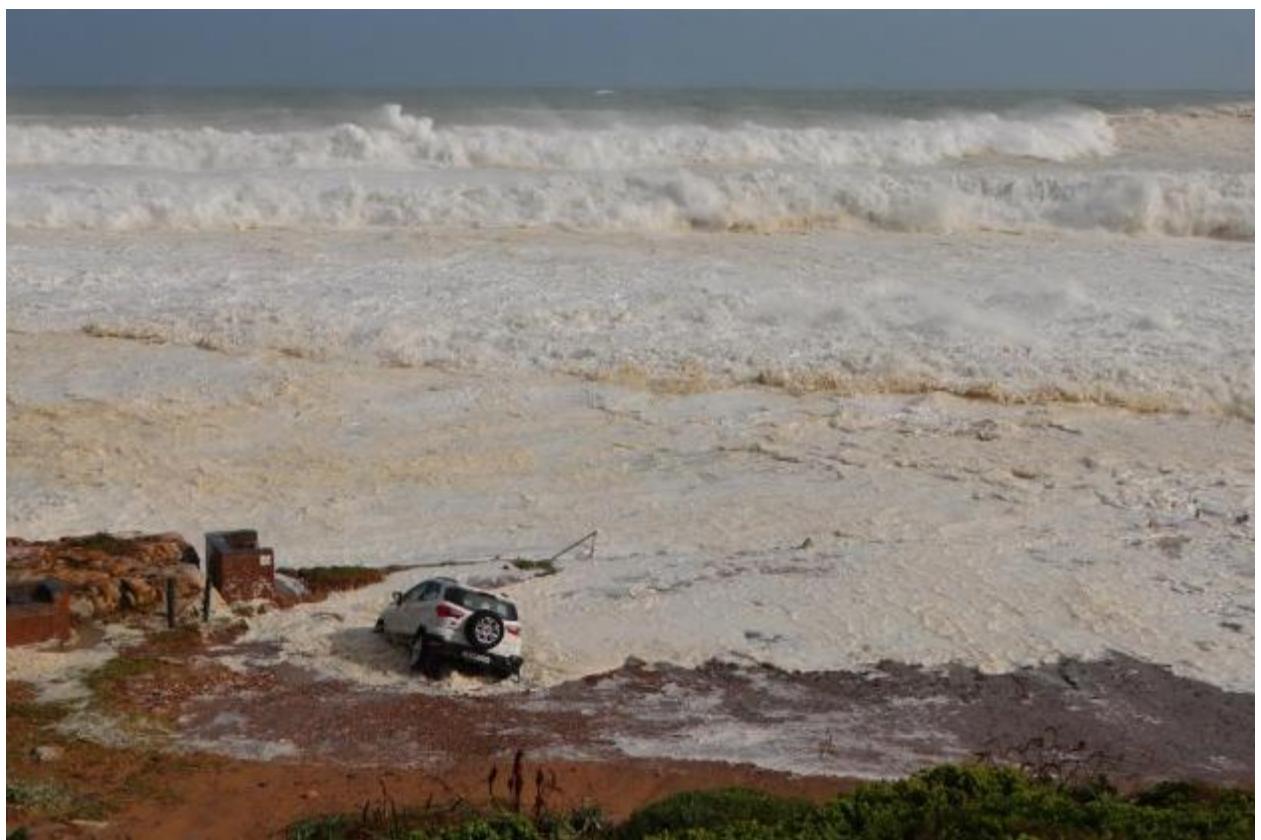
Figure 11 Vehicle wrecked above tidal pool at 15:40 on 16 Sept 2023

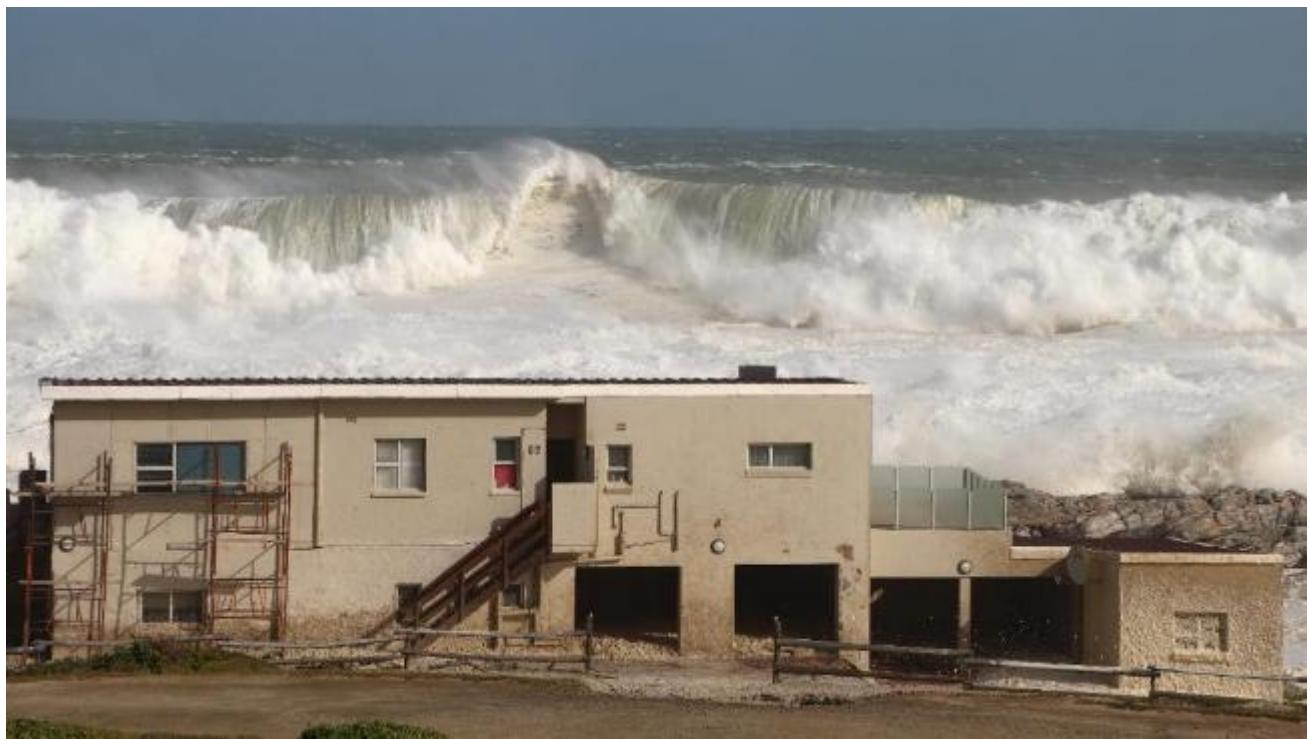
Figure 12 Huge breaking waves behind house at 59 Main Road at 15:48 on 16 Sept 2023. Notice foam and water damage landward of house!

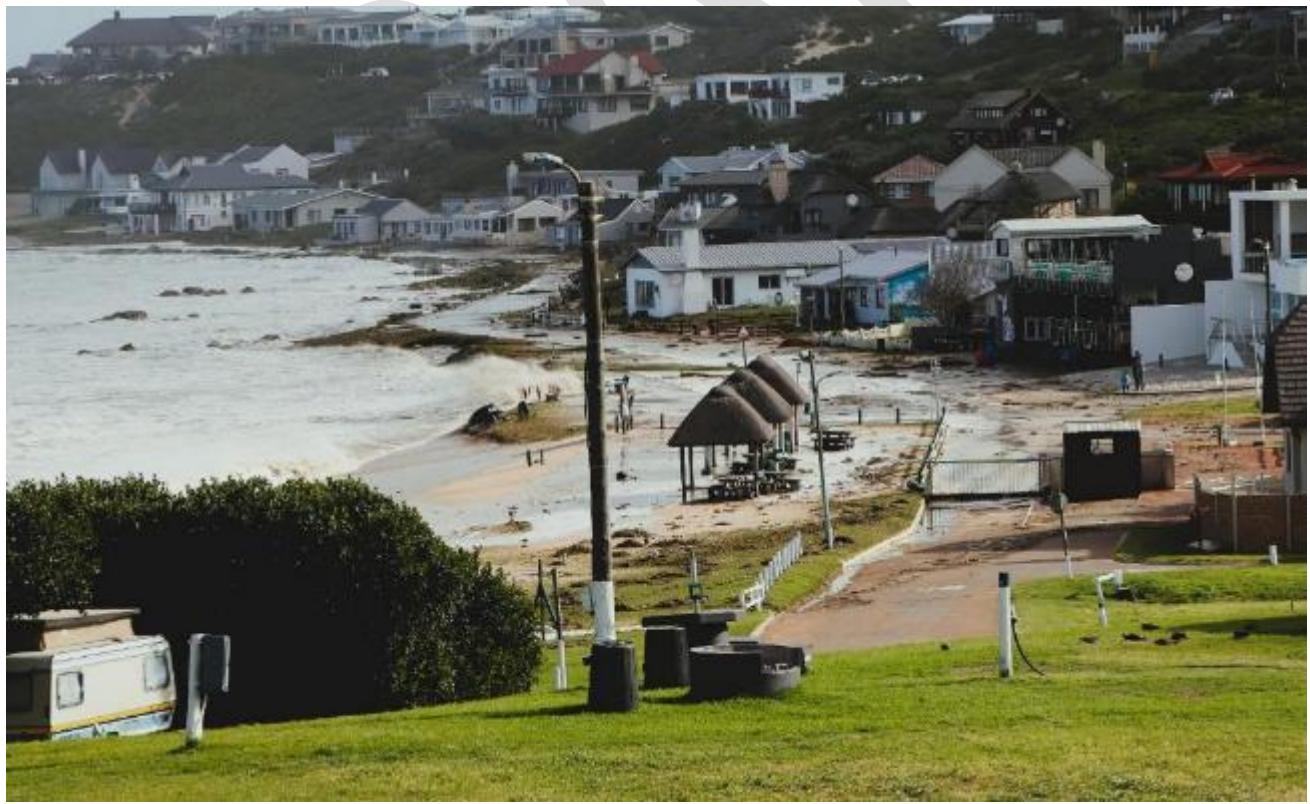
Figure 13 Strand Street from camp site at 15:58 on 16 Sept 2023. Notice debris all along Strand Street.

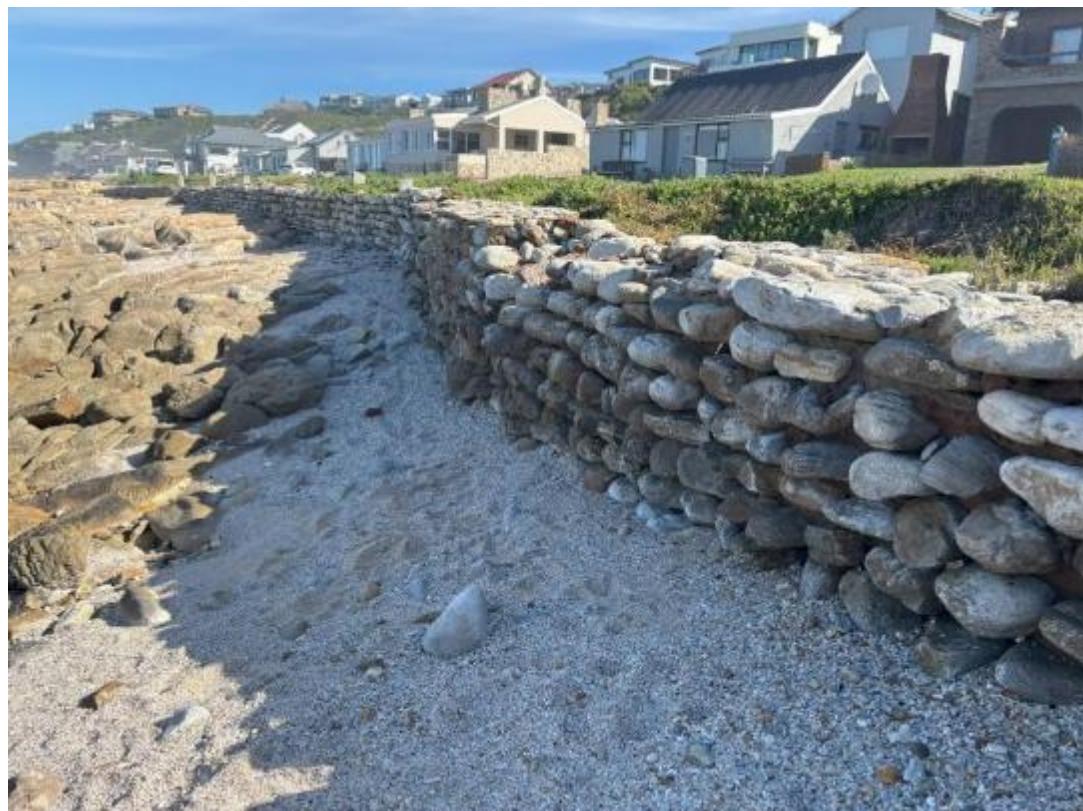
Figure 38 View from ocean side of natural rock masonry retaining wall from Ch320 southwards. Wall aesthetically pleasing and blends in with natural surroundings. Note however damage on top side from storm/flood events

Provided the existing wall is structurally sound and can carry the additional load of a parapet wall this will be the most cost-effective alternative since more than half the seawall is already in place. In addition, the seawall with the natural rock base will not be foreign and blend in with the existing surroundings.

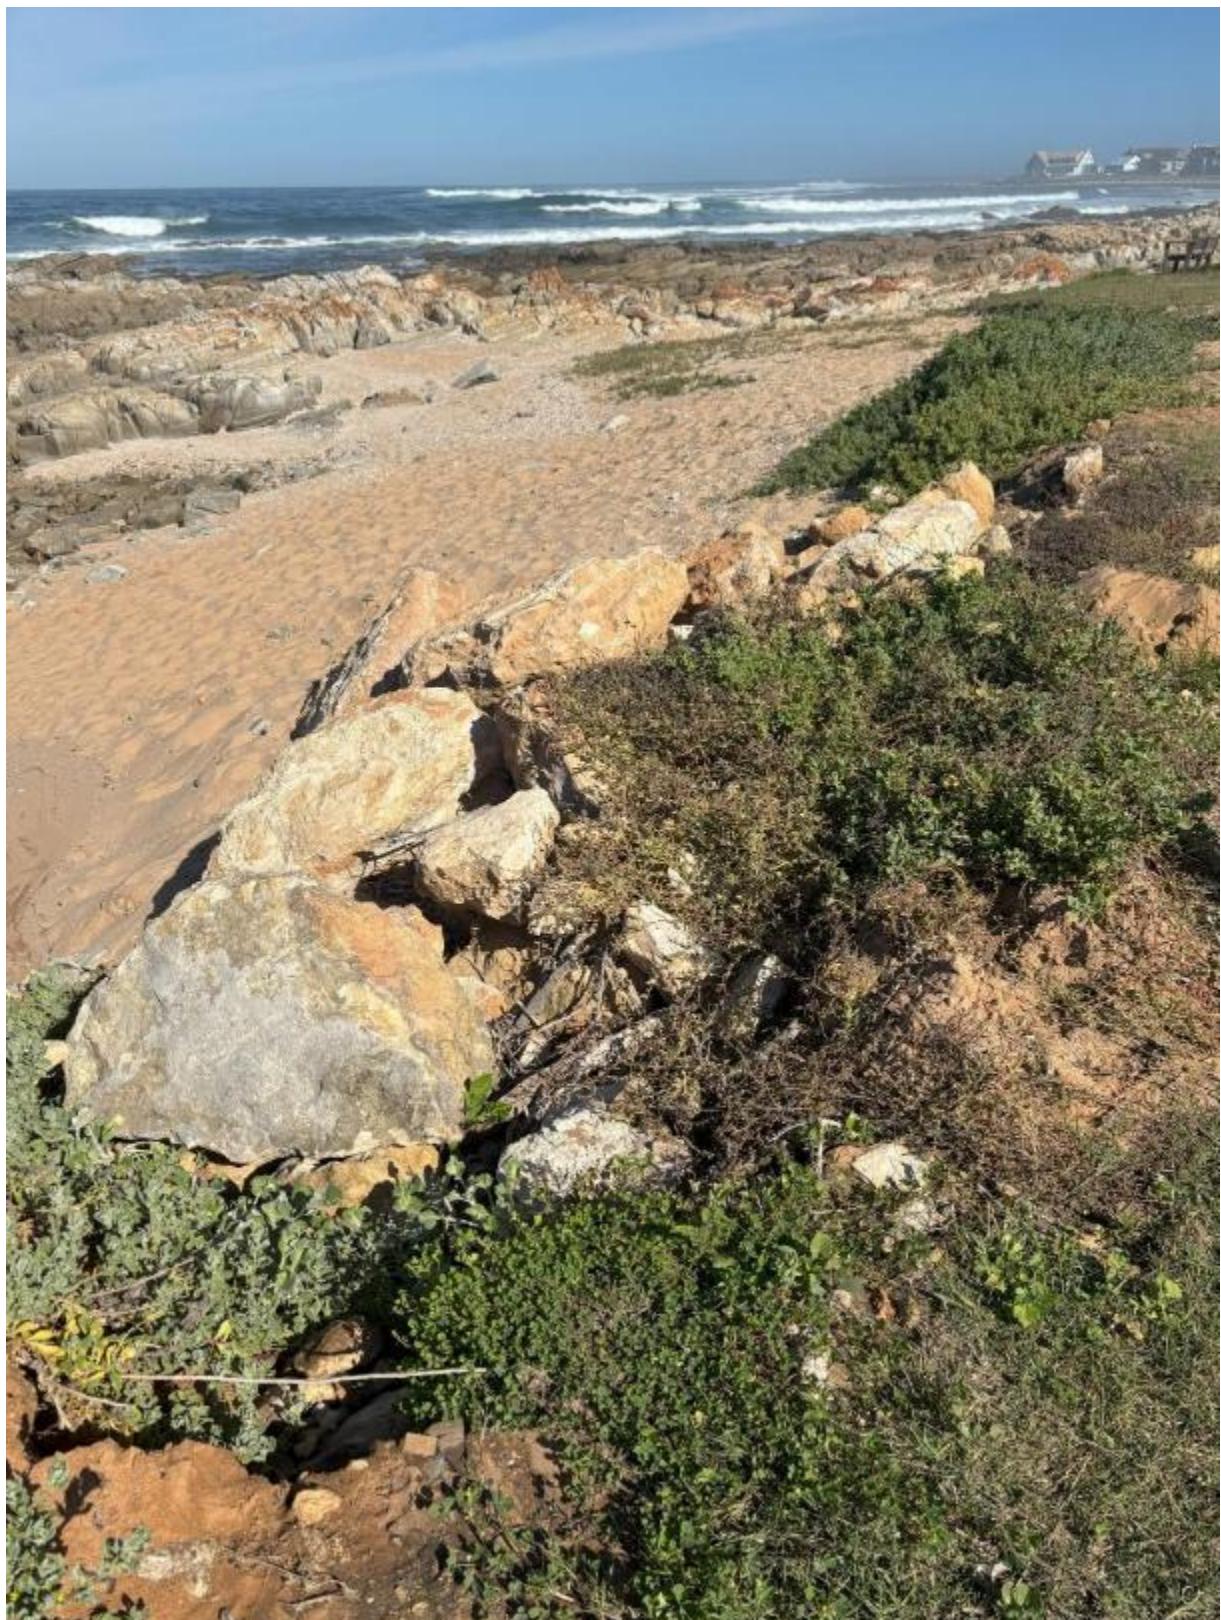
Figure 43 Ch125 looking southwards untidy and not very ineffective rock revetment supporting lawn/vegetation alongside roadway. Sound sandy upper beach area

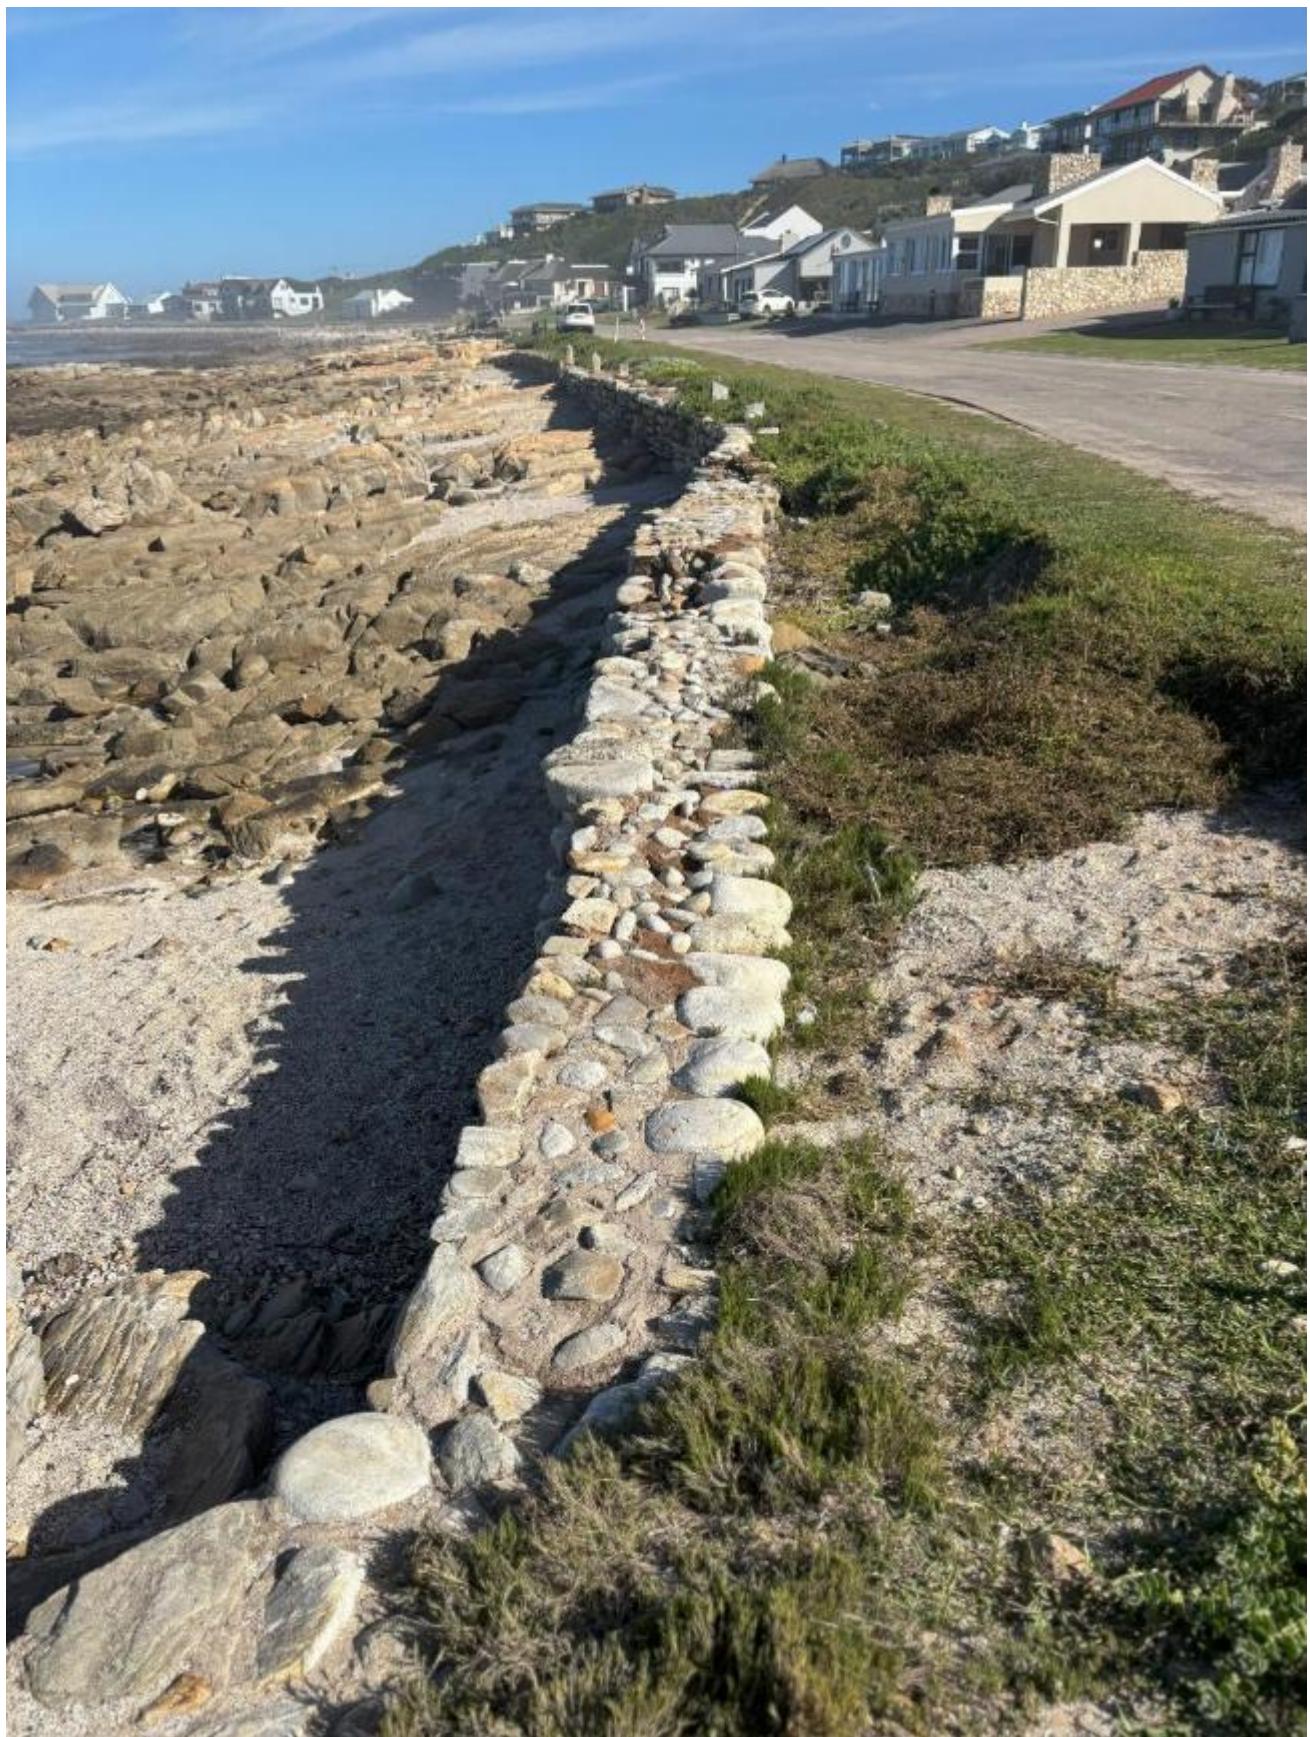
- Along the central section (from Ch300 to Ch350) erosion scars are observed on the verge as a result of storm/flood events – likely the Sept 2023 ocean storm and the May 2021 and March 2023 intense rainfall events.

Figure 50 Natural rock masonry retaining wall from Ch320 southwards creates a 3m to 3.5m wide verge for pedestrian use – largely vegetated but showing erosion scars from storm/flood events

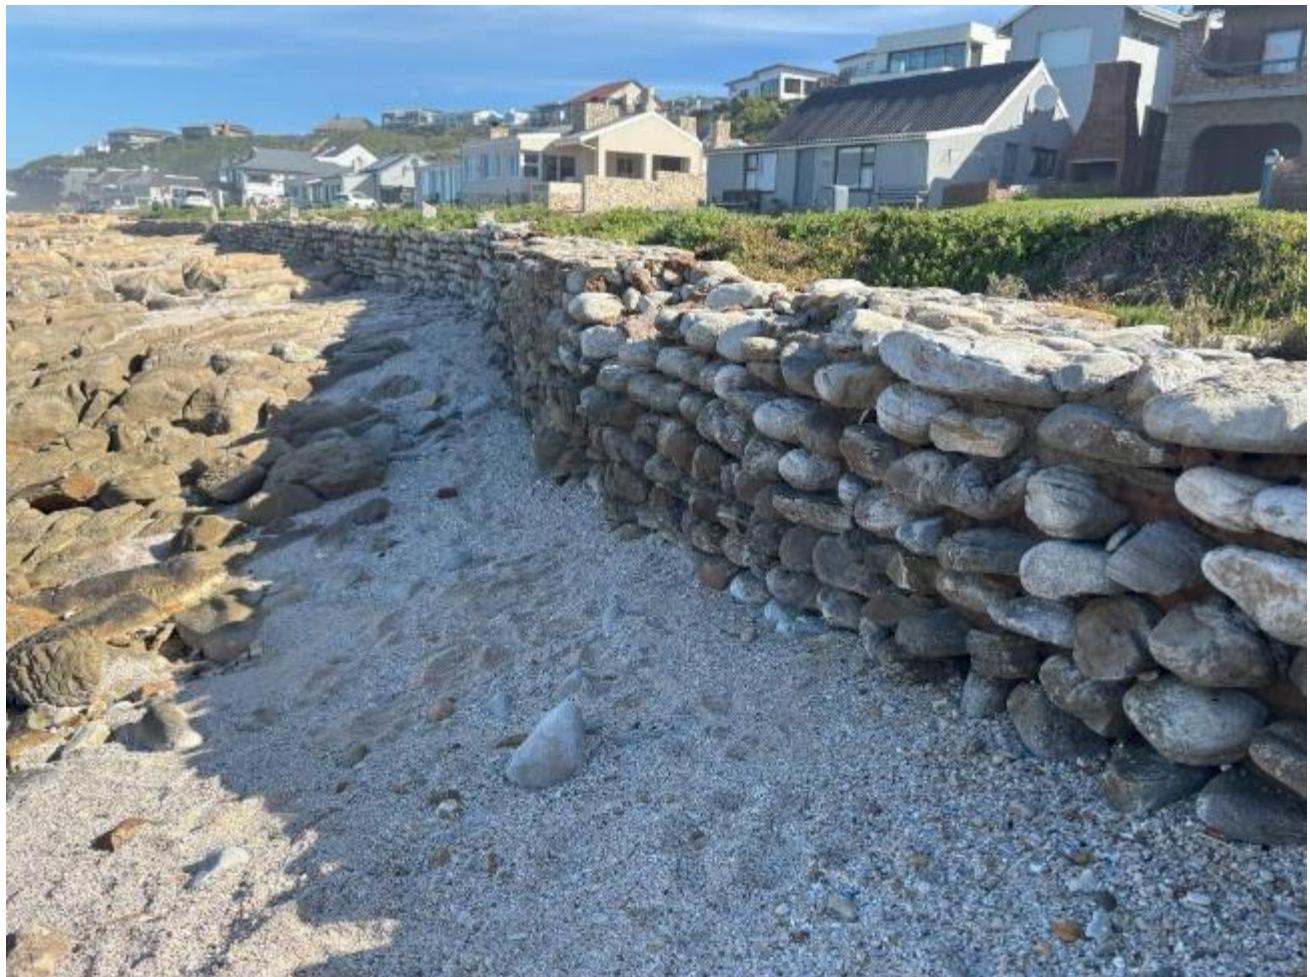
- The retaining wall is in reasonable condition, but damage was observed at a number of locations. If left unmaintained this is likely to result in further local deterioration and eventual local failure.

Figure 51 View from ocean side of natural rock masonry retaining wall from Ch320 southwards. Wall aesthetically pleasing and blends in with natural surroundings. Note however damage on top side from storm/flood events

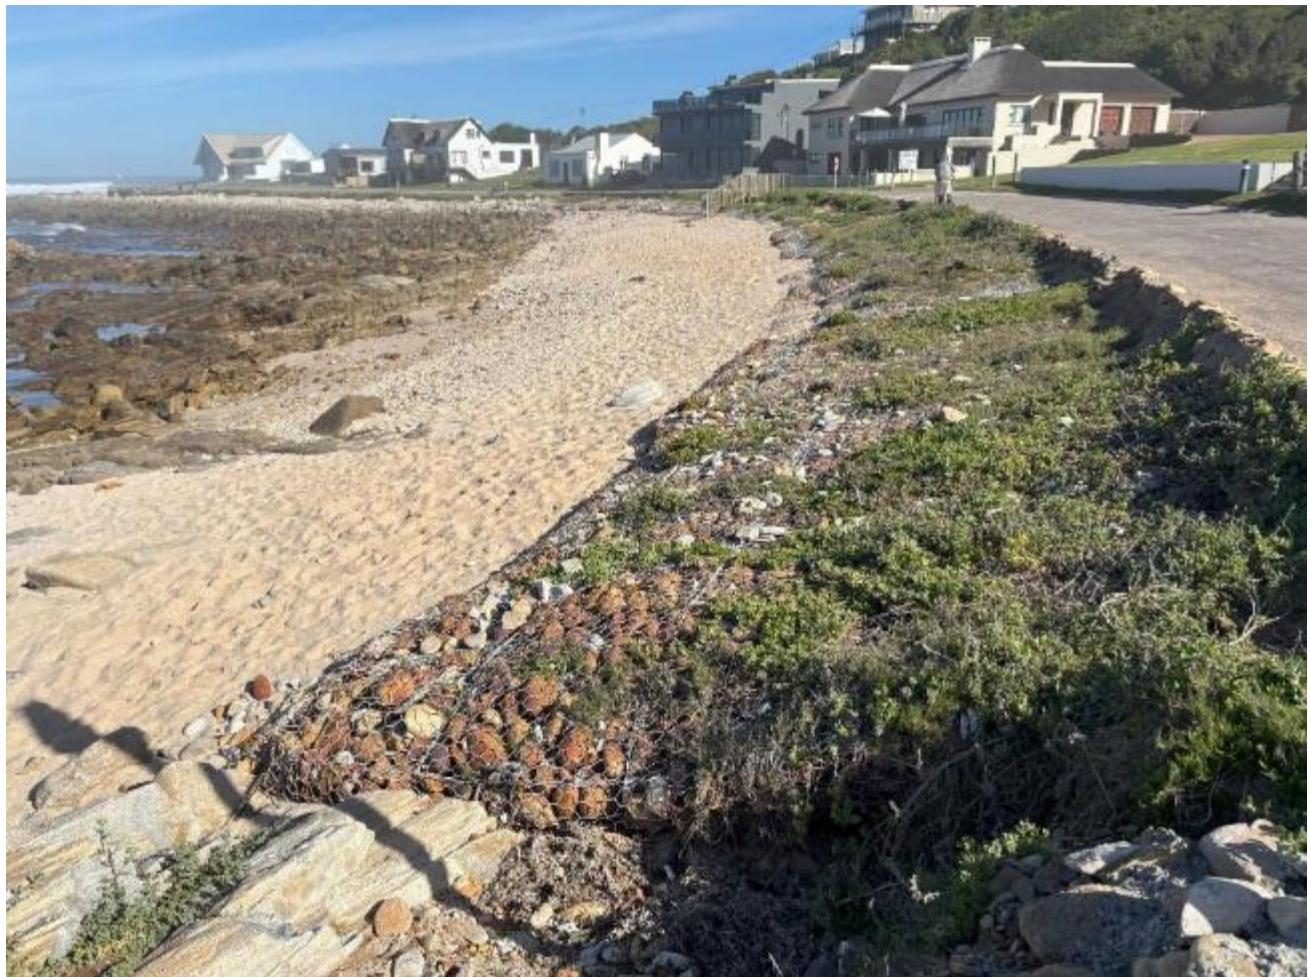
- Gabion mattress edging, some 4 m wide, forms the verge below the roadway for about 100 m length, from approx. Ch510 to Ch610. While effective in protecting the roadway these wire structures are unsightly and sterilise valuable space on the beach from users. While some vegetation growth has taken place the area is largely not vegetated. Also wire mattresses have been damaged which could lead loss of rock and failure of structure in future: injuries to beach users also possible, especially kids, due to sharp protruding wires.

Figure 58 Gabion mattress edging below low natural rock retaining/edge wall from approx. Ch510. While effective in protecting the roadway these wire structures are unsightly and sterilise valuable space on the beach from users. While some vegetation growth has taken place the area is largely not vegetated. Also wire mattresses have been damaged which could lead loss of rock and failure of structure in future: injuries to beach users also possible, especially kids, due to sharp protruding wires

The gabion mattresses are left in position, but where their condition has deteriorated, repairs are done to yield an aesthetically pleasing structure. A wooden pedestrian walkway is constructed all along Strand Street above the gabion mattress section. An indicative cross-section is provided below.

A walkway similar to that at Witsand is installed. The gabion mattresses are thus removed and replaced by an earthworks mound protected on the seaward side by rock armour, possibly in a mortar base and with a brick pavement layer on the structure crest (more-or-less at the road surface level). See indicative section in sketch below.

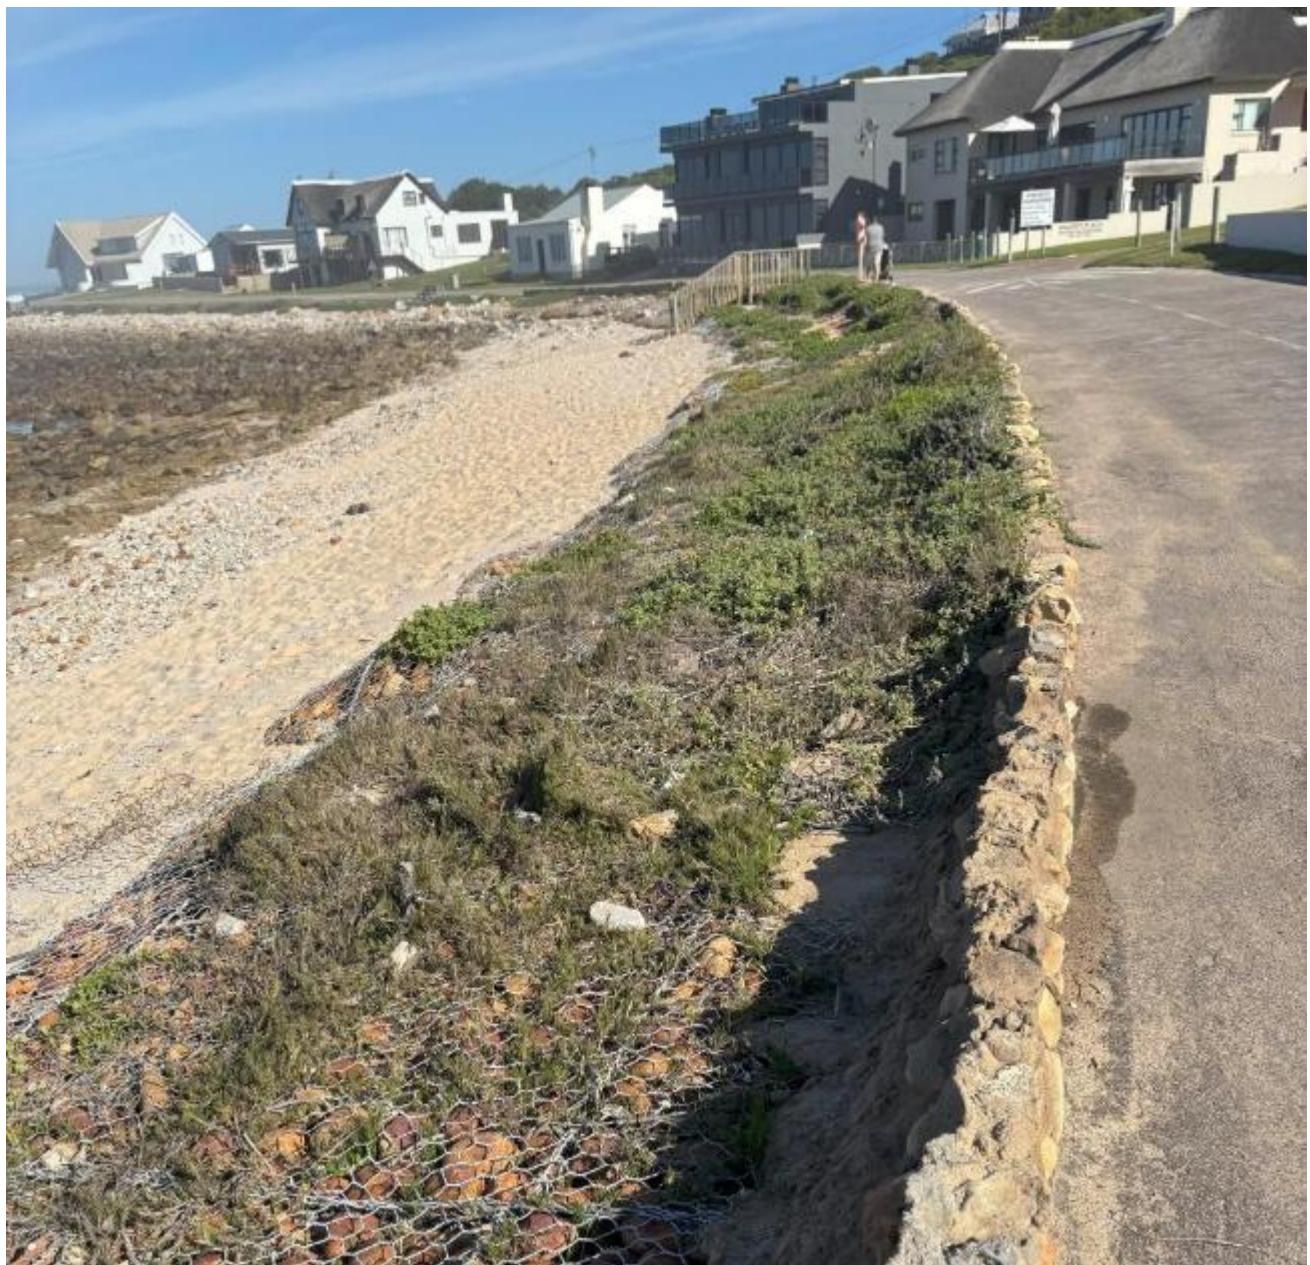
Figure 59 Gabion edging below low natural rock wall Ch550. While effective in protecting roadway these wire structures are unsightly and limit use of valuable space on the beach.

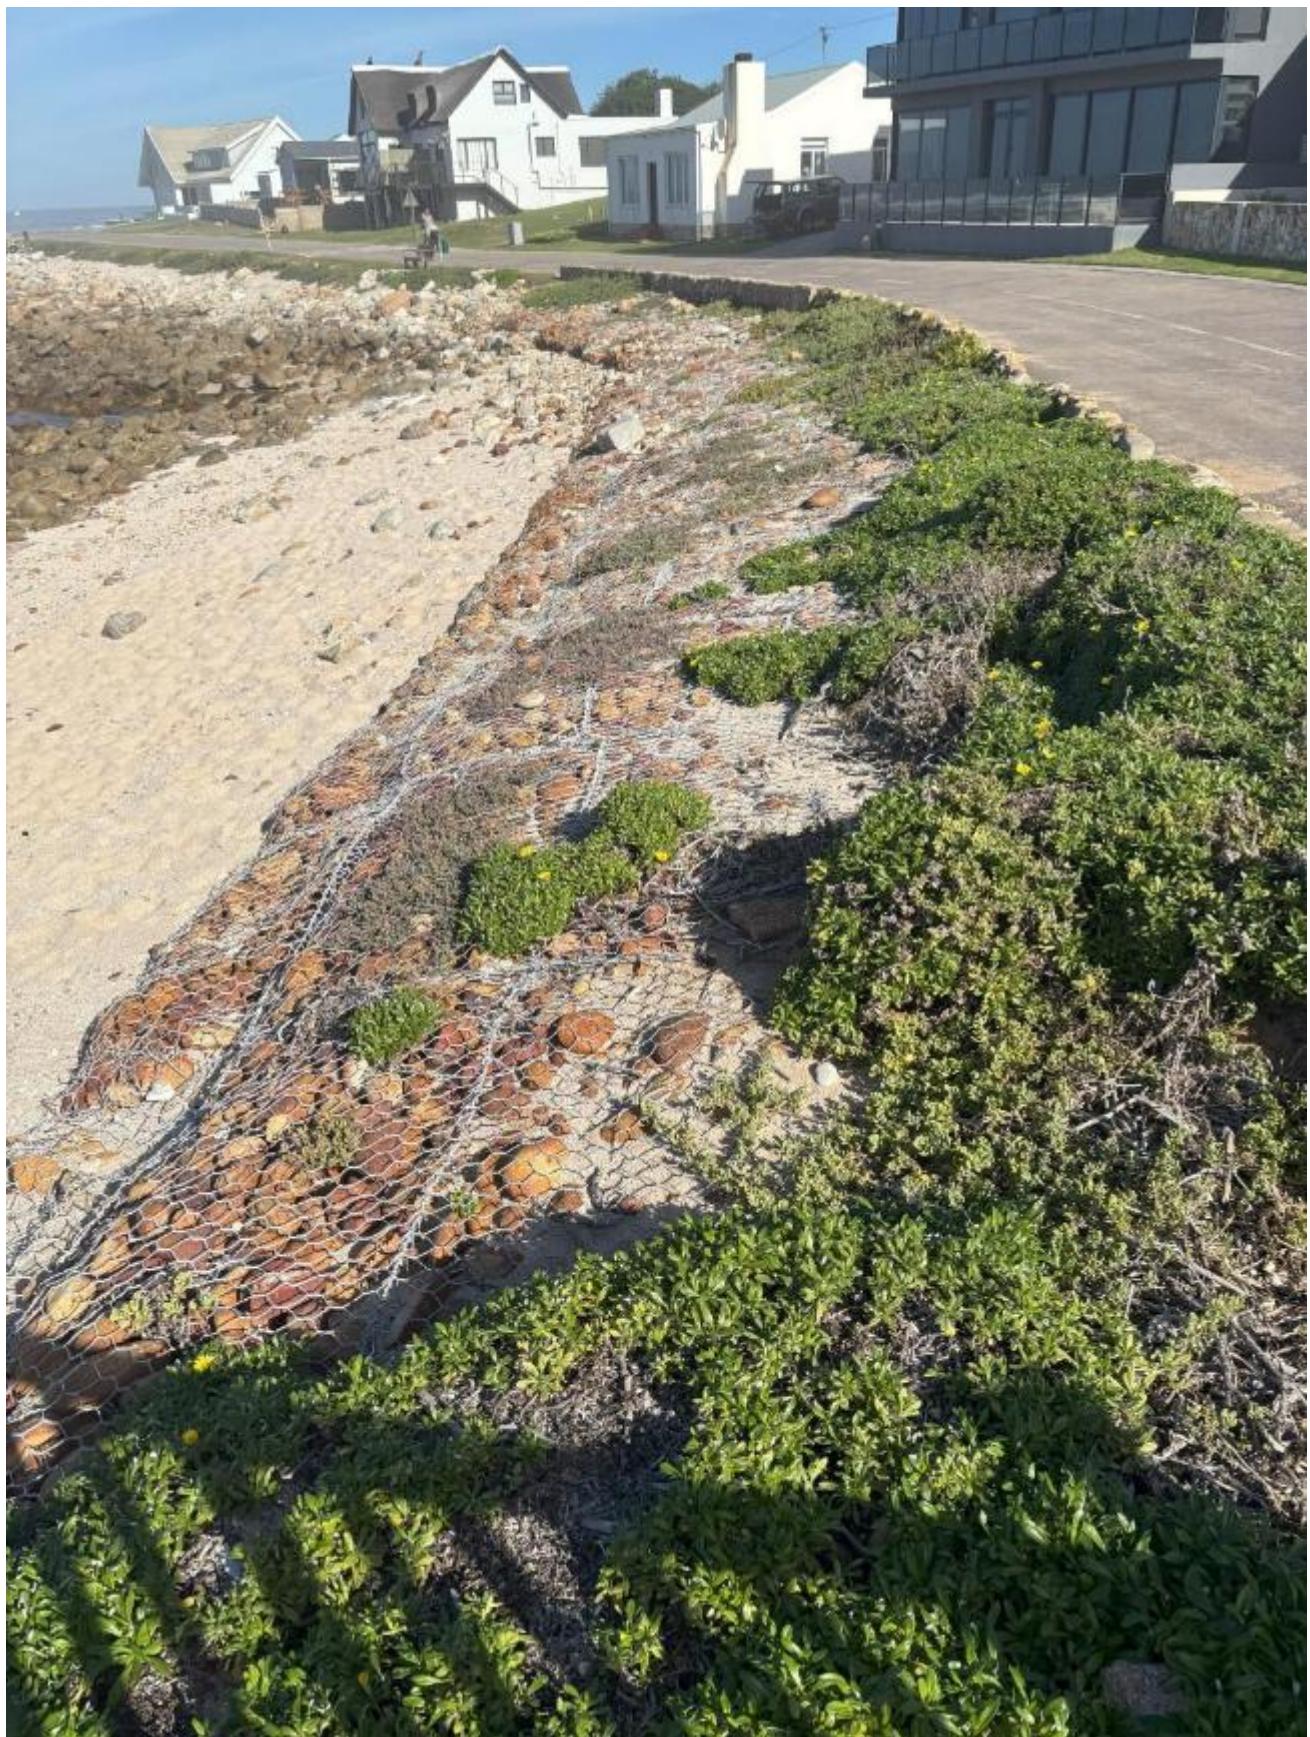
Figure 62 Southward view from access bridge at Ch570: Pedestrian-unfriendly gabion mattress verge above sandy beach area

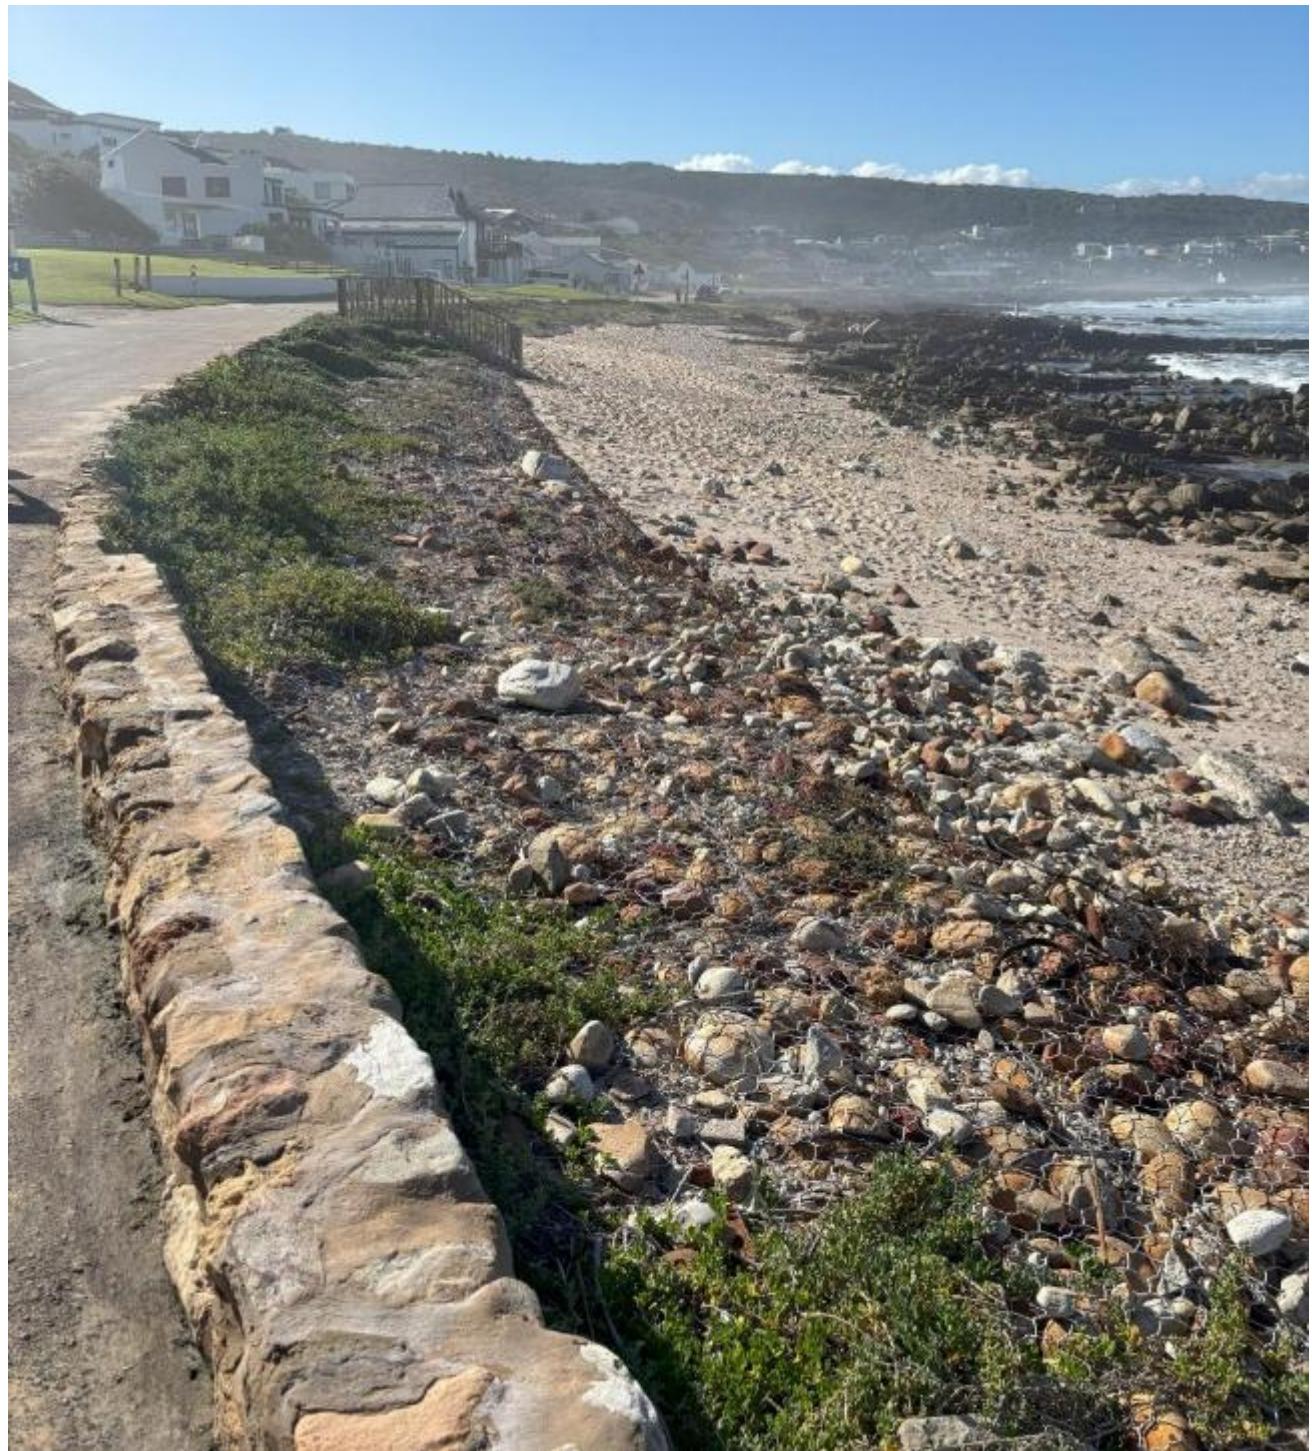
Figure 65 Northward view from Ch600: Note unsightly exposed and damaged wiring from gabion mattresses. Also newly reconstructed 'double' rock retaining wall in foreground This new wall has length of some 25m
