# JONGENSFONTEIN PROMENADE

## Motivation and Preliminary Development Concept – DRAFT REPORT

This report provides an assessment of the vulnerability and risk associated with the Strand Street shoreline interface from a coastal engineering perspective, and makes recommendations of possible structural interventions to address flooding and associated risks.

This report was written by coastal engineering specialist Dr André van Tonder, B Eng, Hons B Eng, PhD (Civil Engineering), Pr Eng, for use by the Jongensfontein Ratepayers Association (JRA).

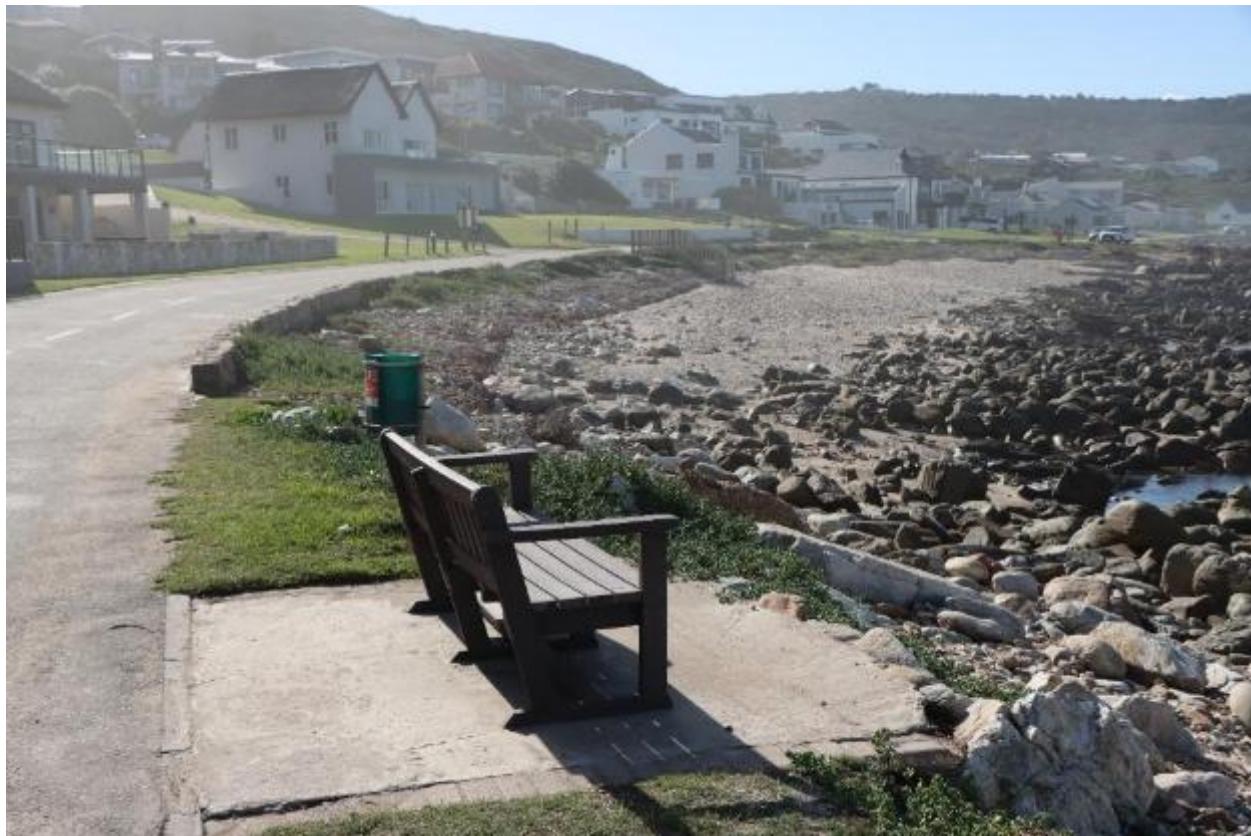
Figure 1 View of Strand Street interface with the ocean

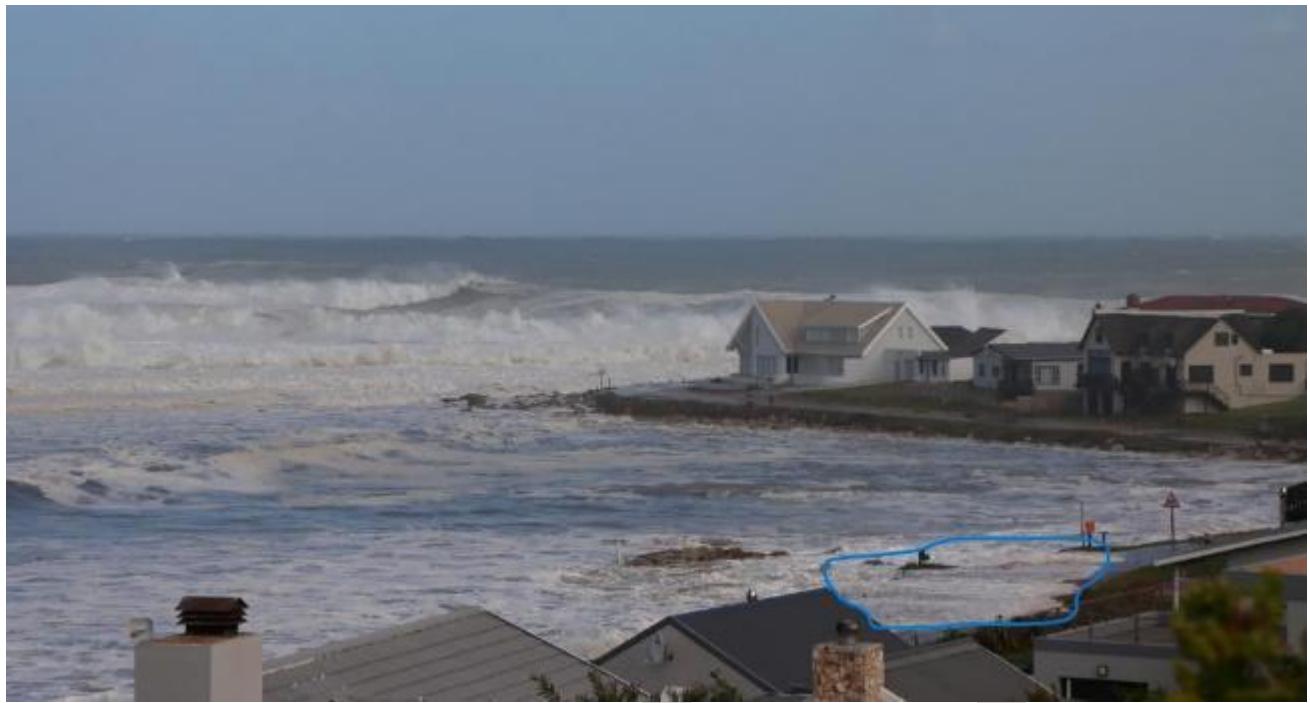
Figure 8 Strand Street flooding around Ch 550 at 15:30 on 16 Sept 2023

The storm wind and wave conditions would have caused additional water level setup (storm surge) which raised water levels significantly above the tidal levels as site evidence showed (i.e. Figure 8 to 11).

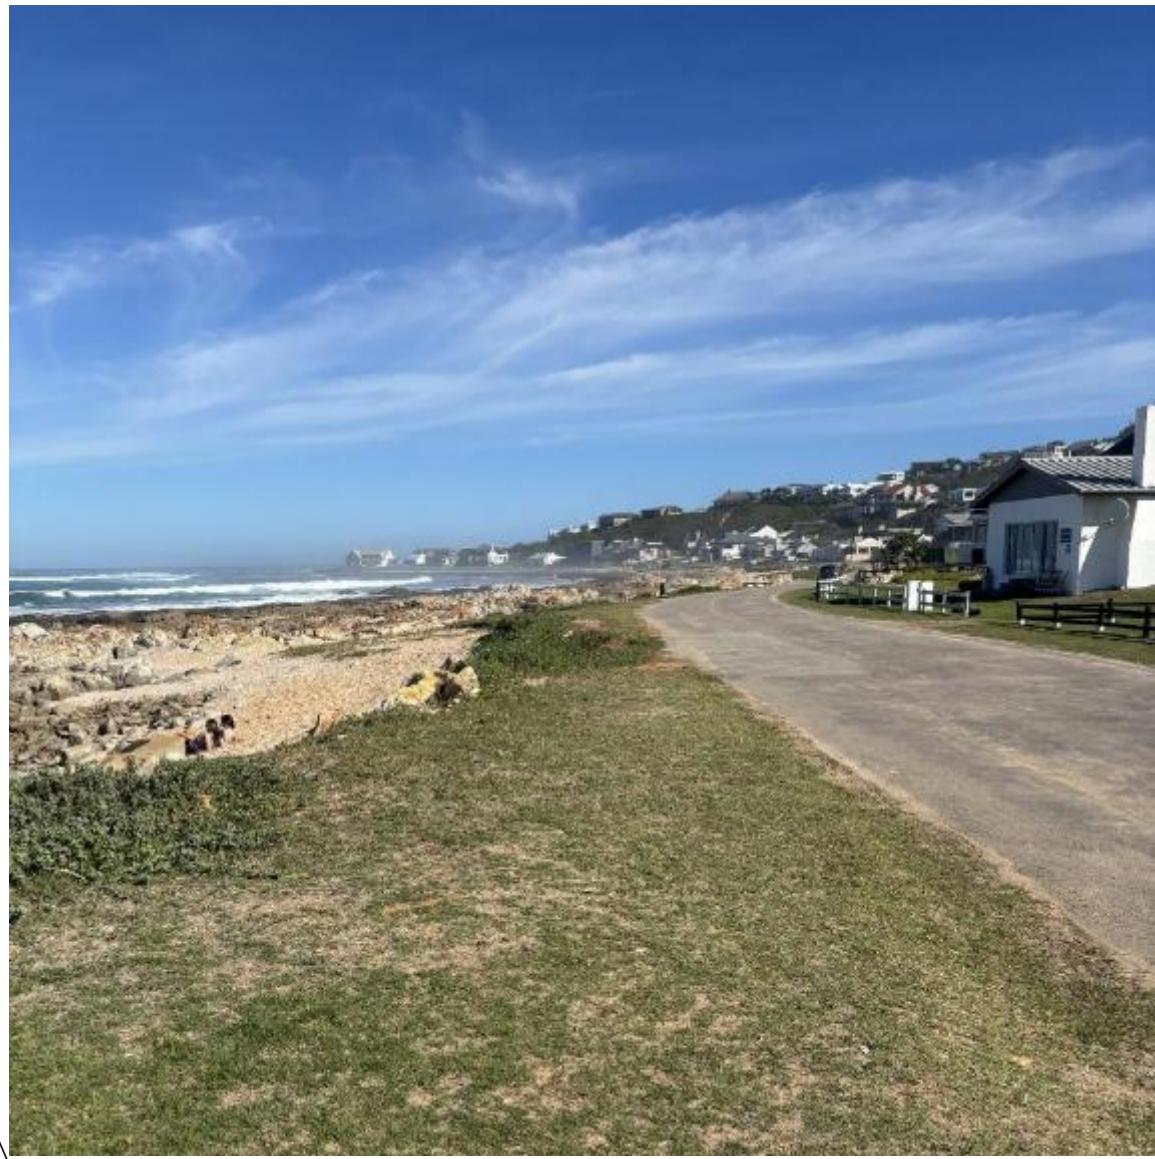
Figure 42 Ch100 looking southwards showing lawn alongside roadway some 5 m width on foreground reducing to about 3 m at Ch110

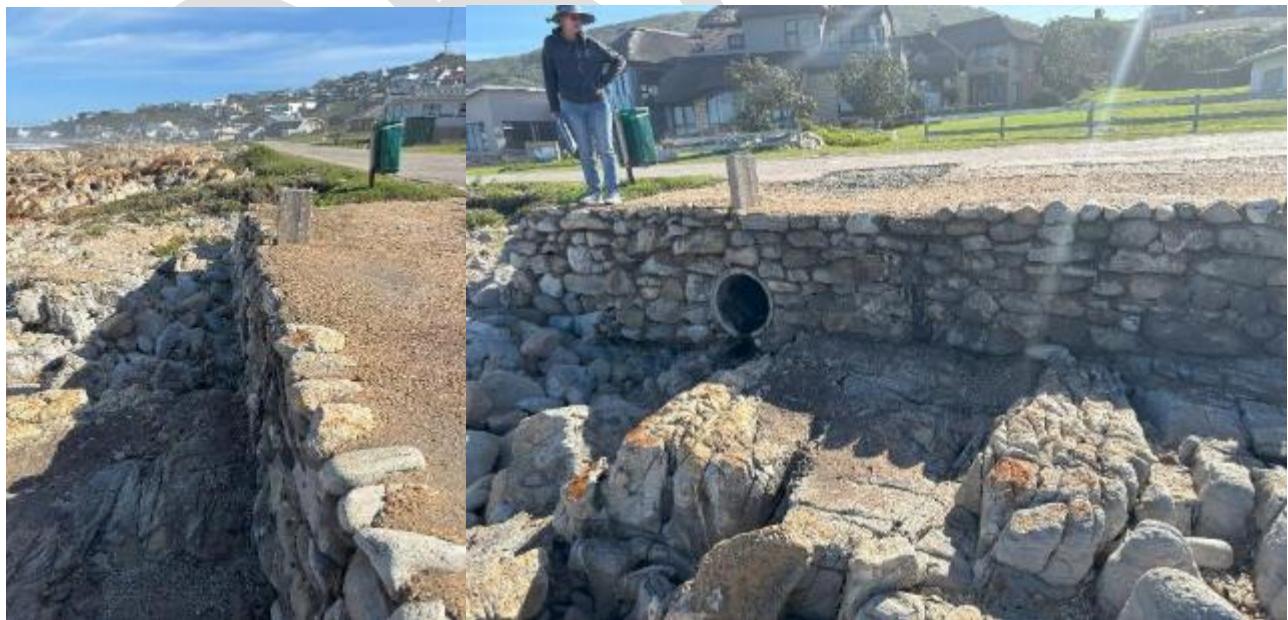
Figure 45 Concreted area with natural rock masonry retaining wall just past Ch150. Note storm water outfall

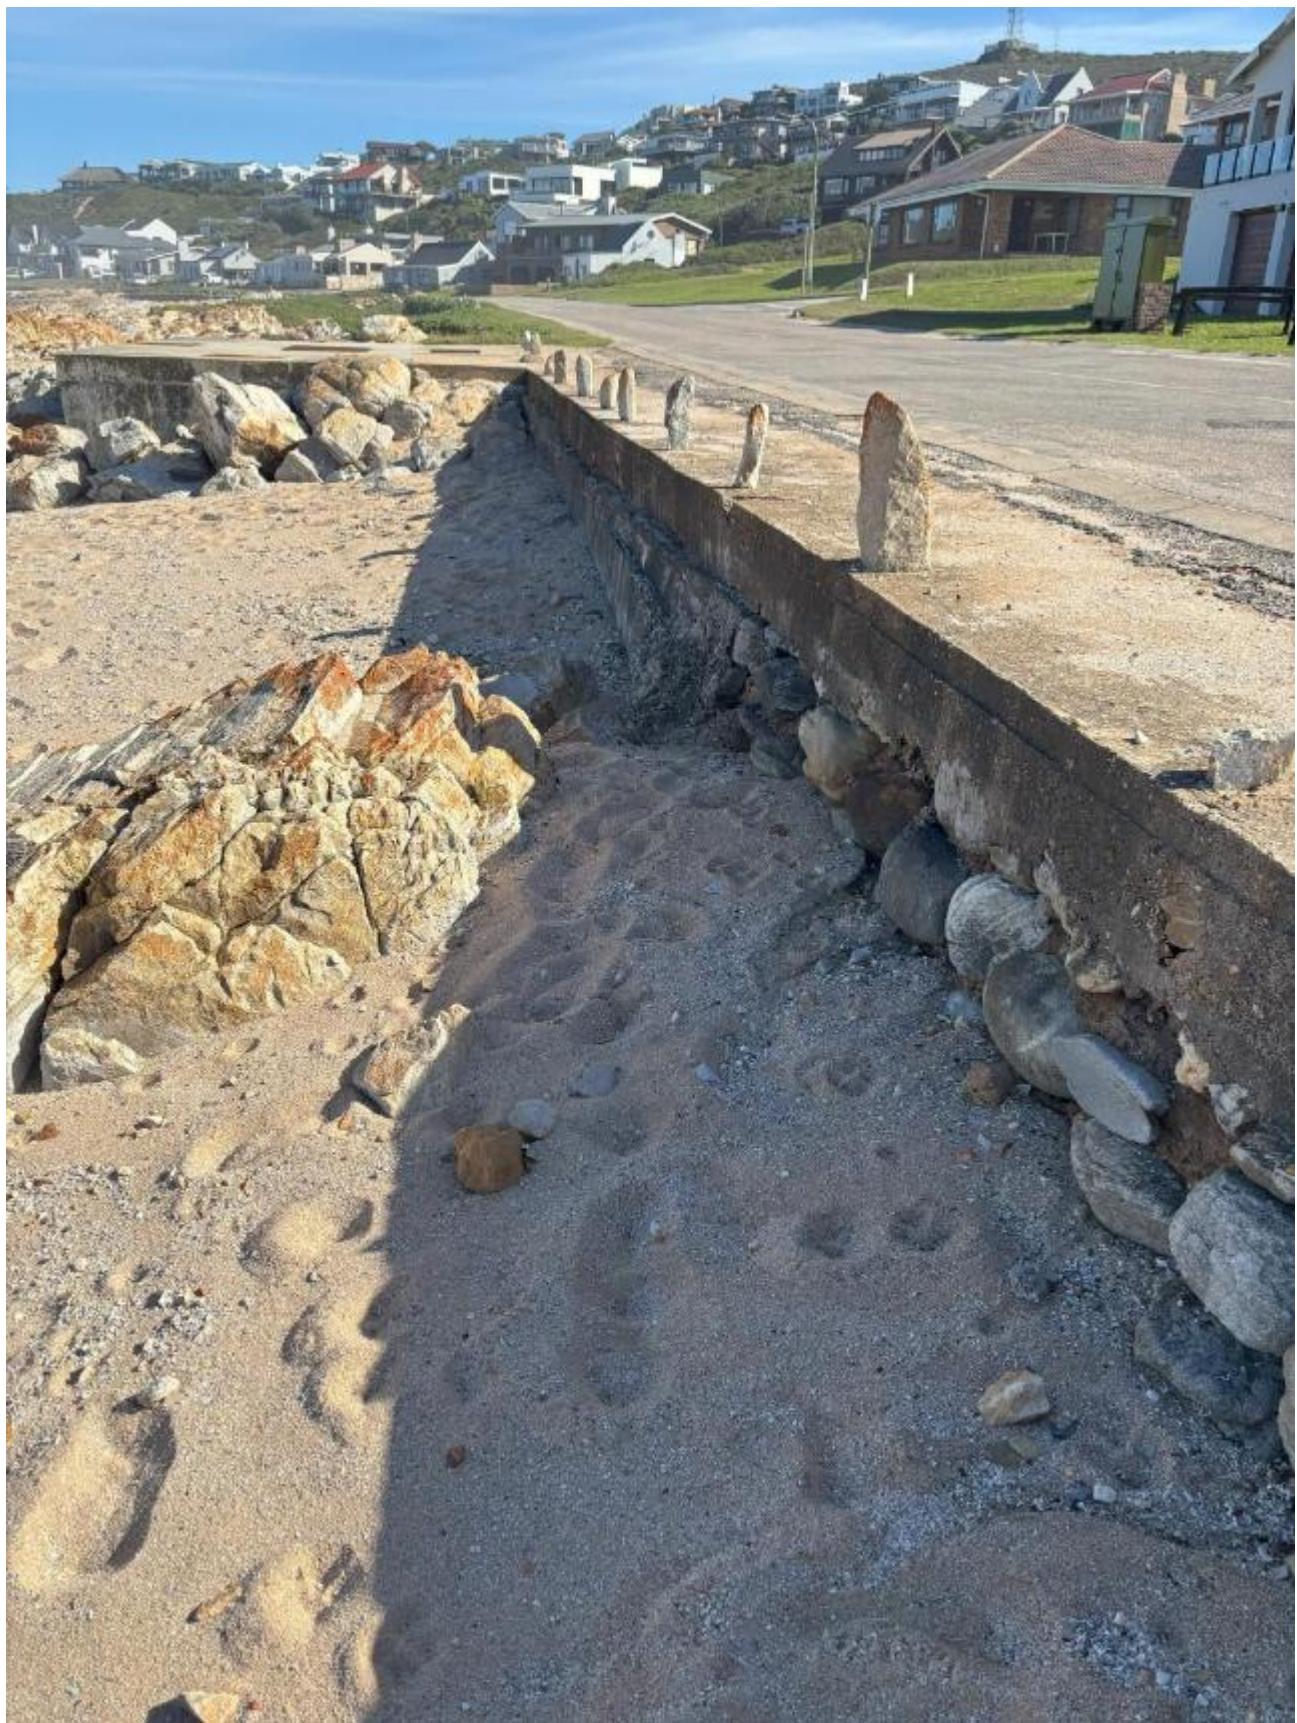
Figure 46 Southward view from Ch200. Note concrete encased sewerage pumpstation (?) and narrow concrete sidewalk/retaining structure with rock boulder foundation on sand(?). Innovative use of upright rocks in concrete as bollards

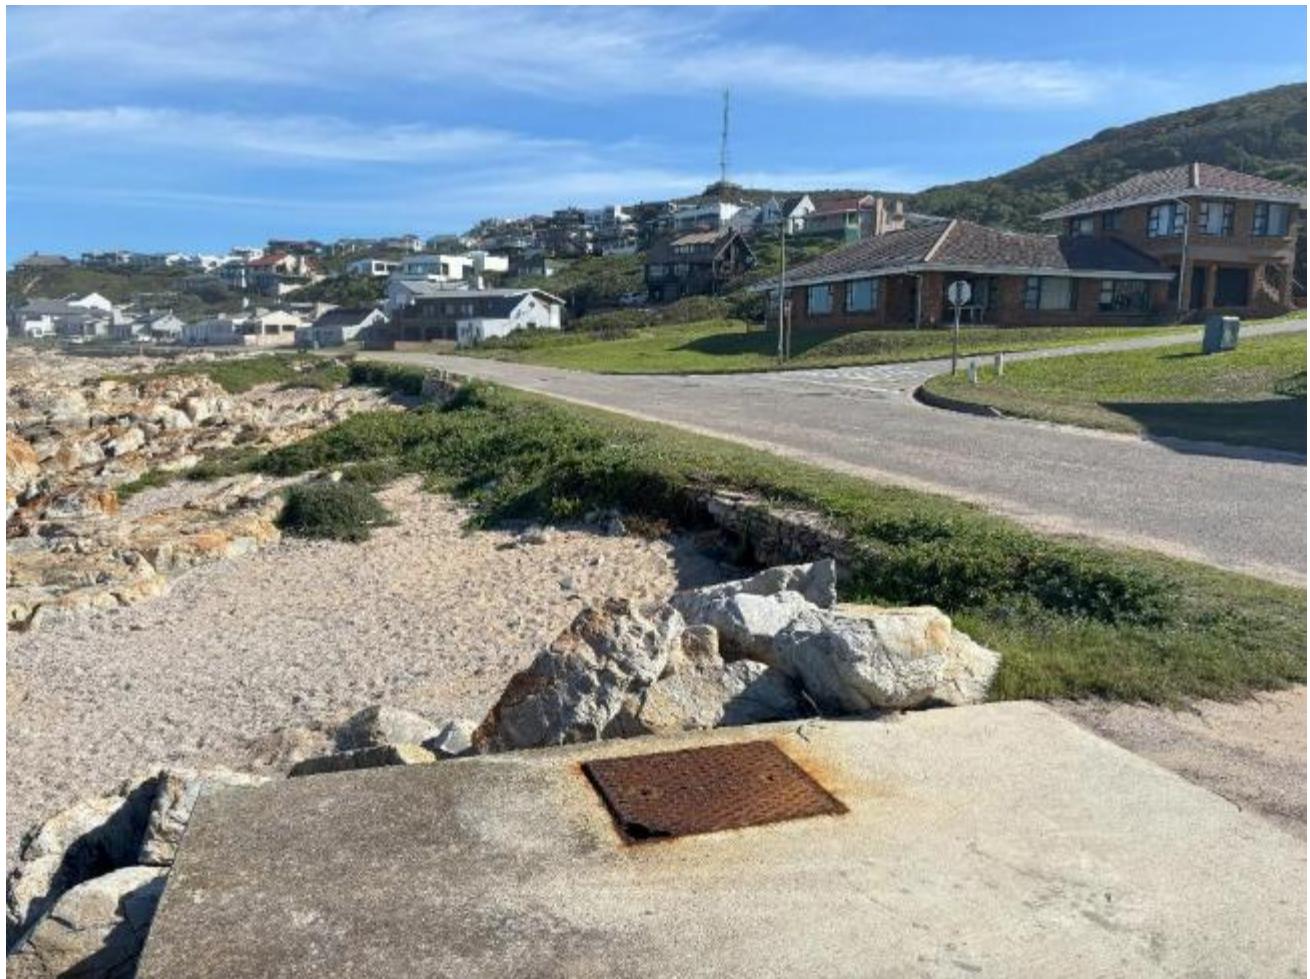
Figure 47 Southward view from pumpstation(?) slab approx. Ch210. Dolfyn Street intersection ahead. Large rock boulders as protection around pumpstation. Natural rock masonry wall adjacent to roadway

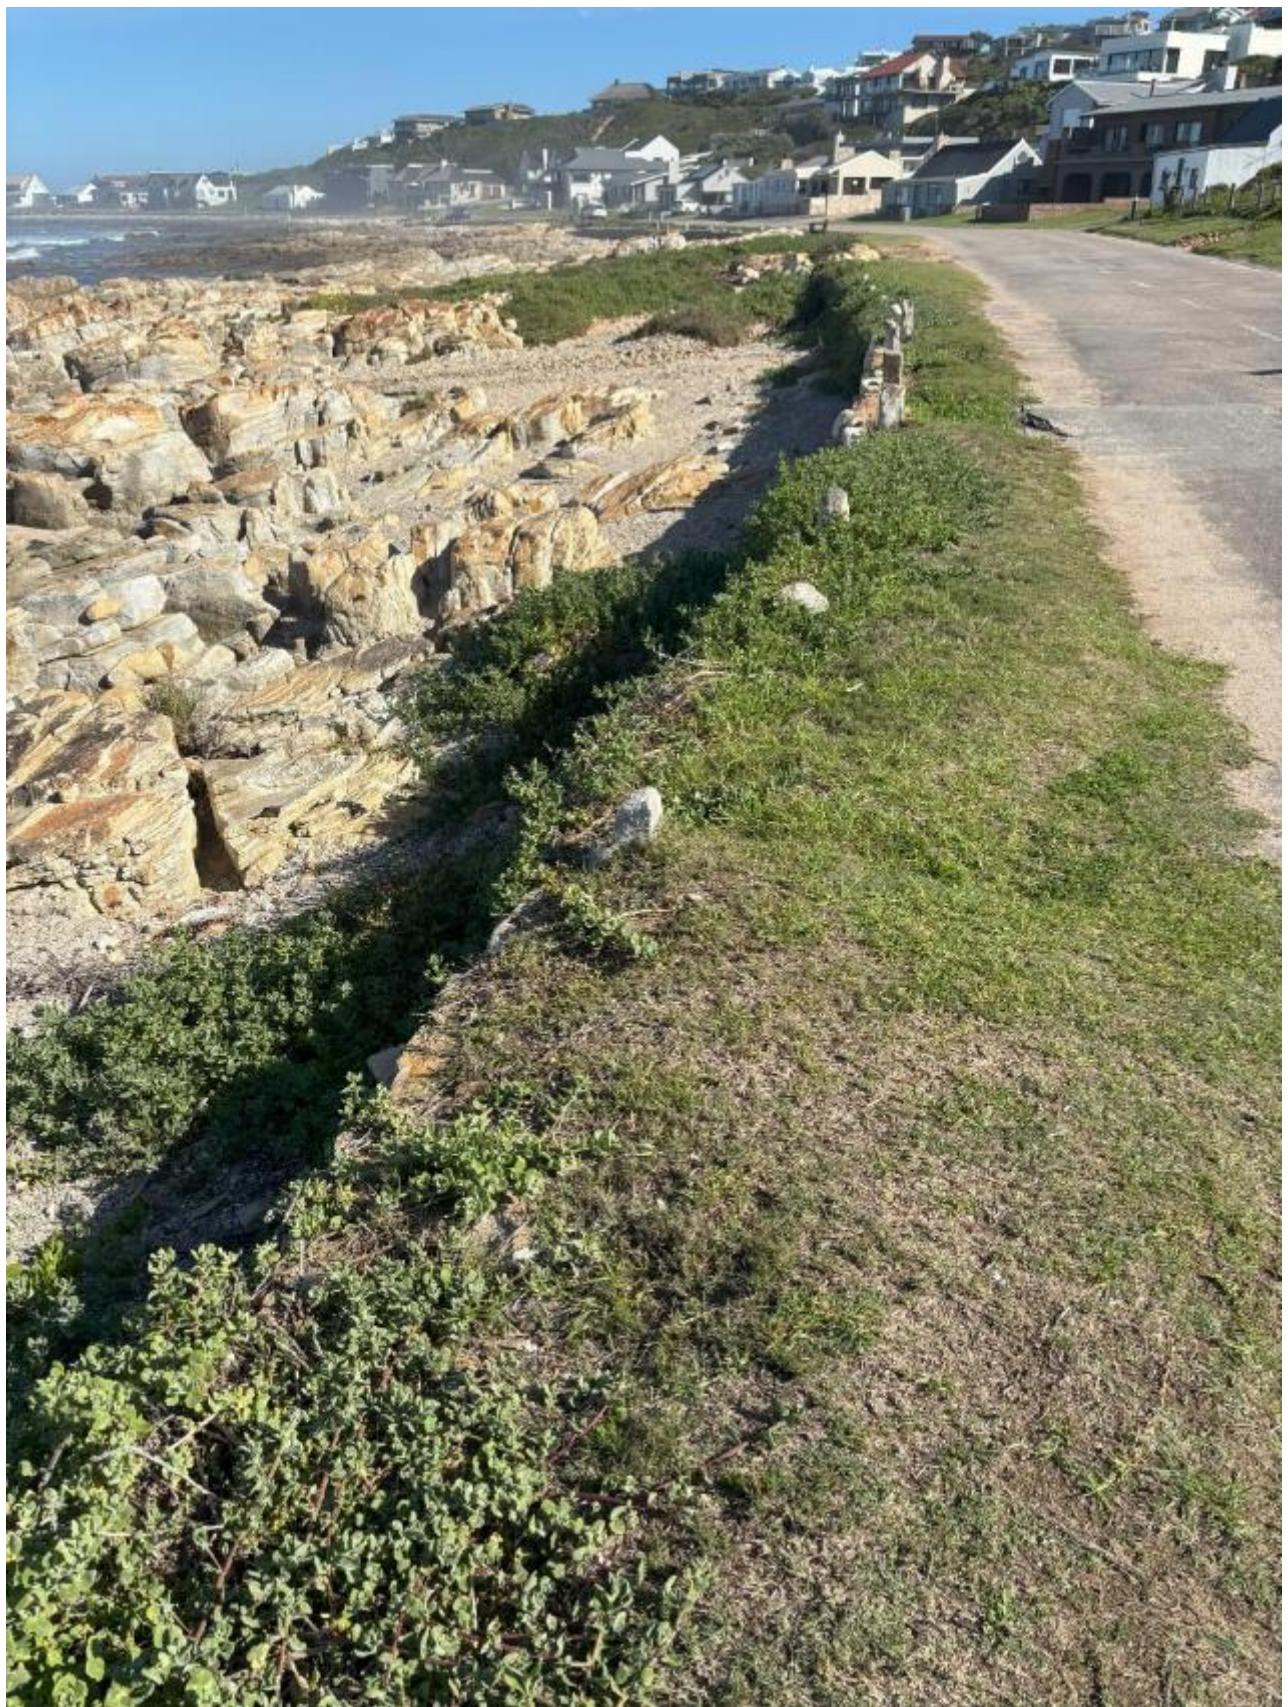
Figure 48 Southward view from Ch250: vegetated verge between 1.5 and 2m in width supported by natural rock masonry wall

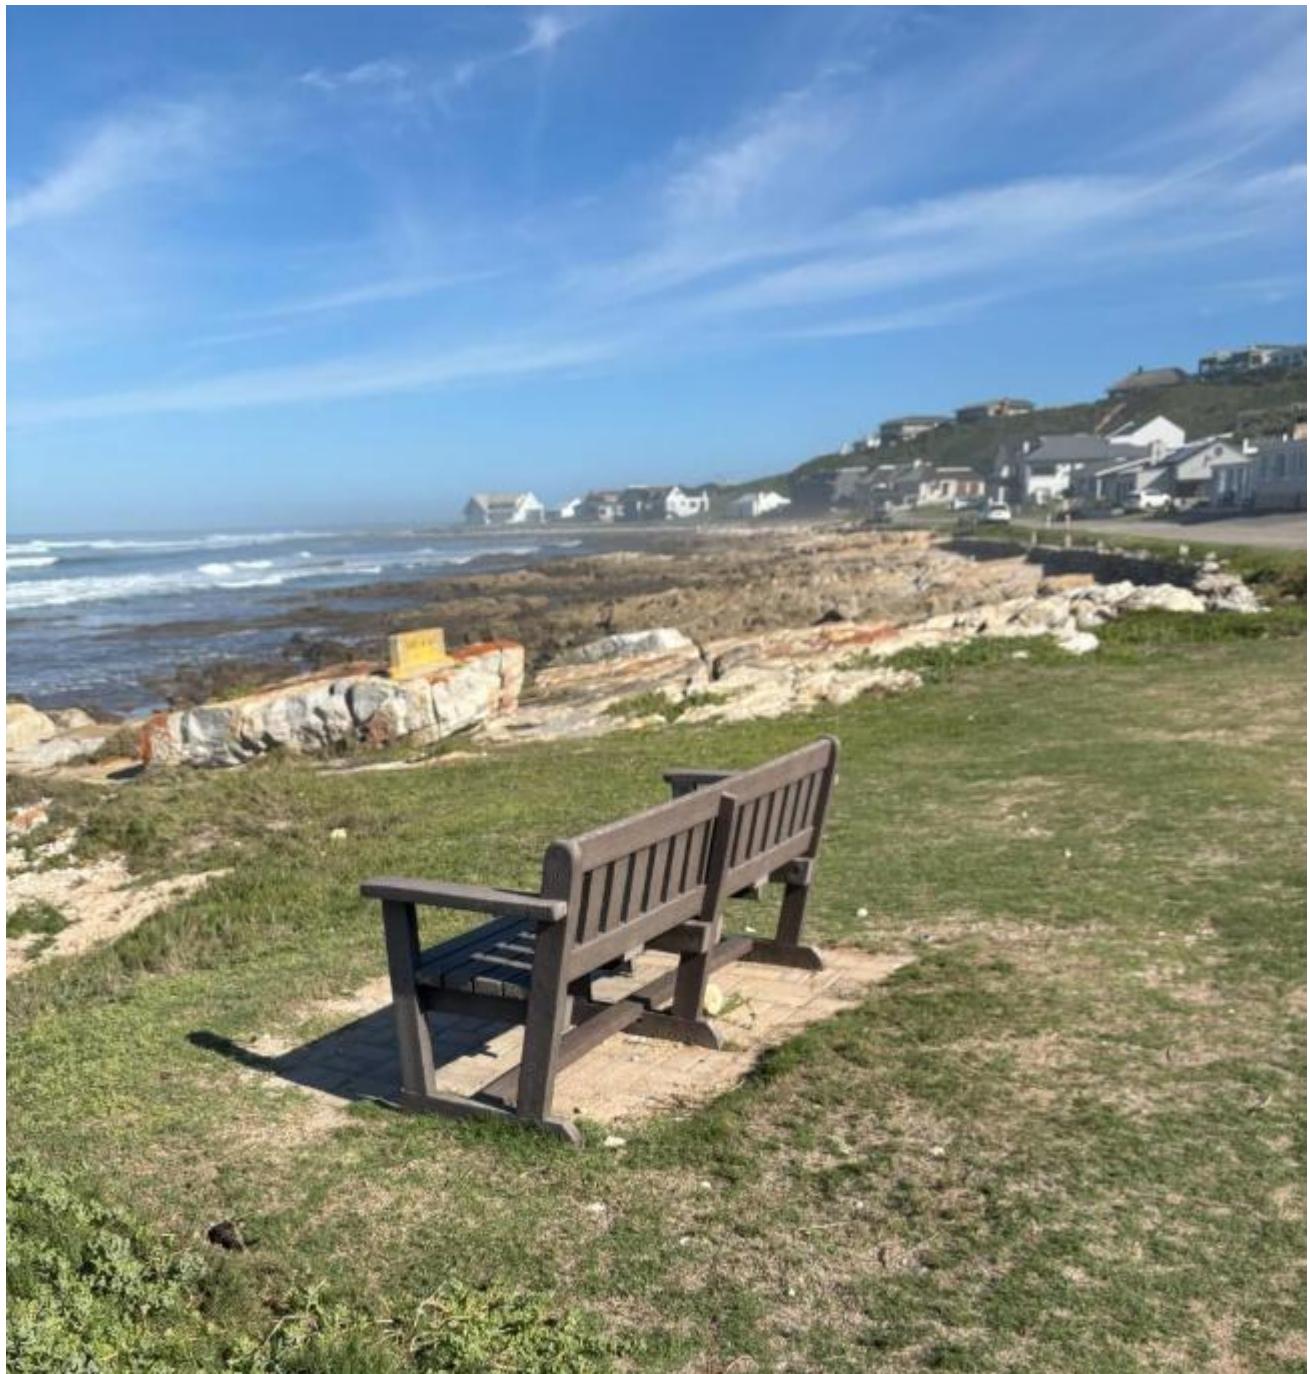
Figure 49 Park bench on wide 6m X 35m area adjecent to roadway at Ch300. Note natural rock masonry wall in distance

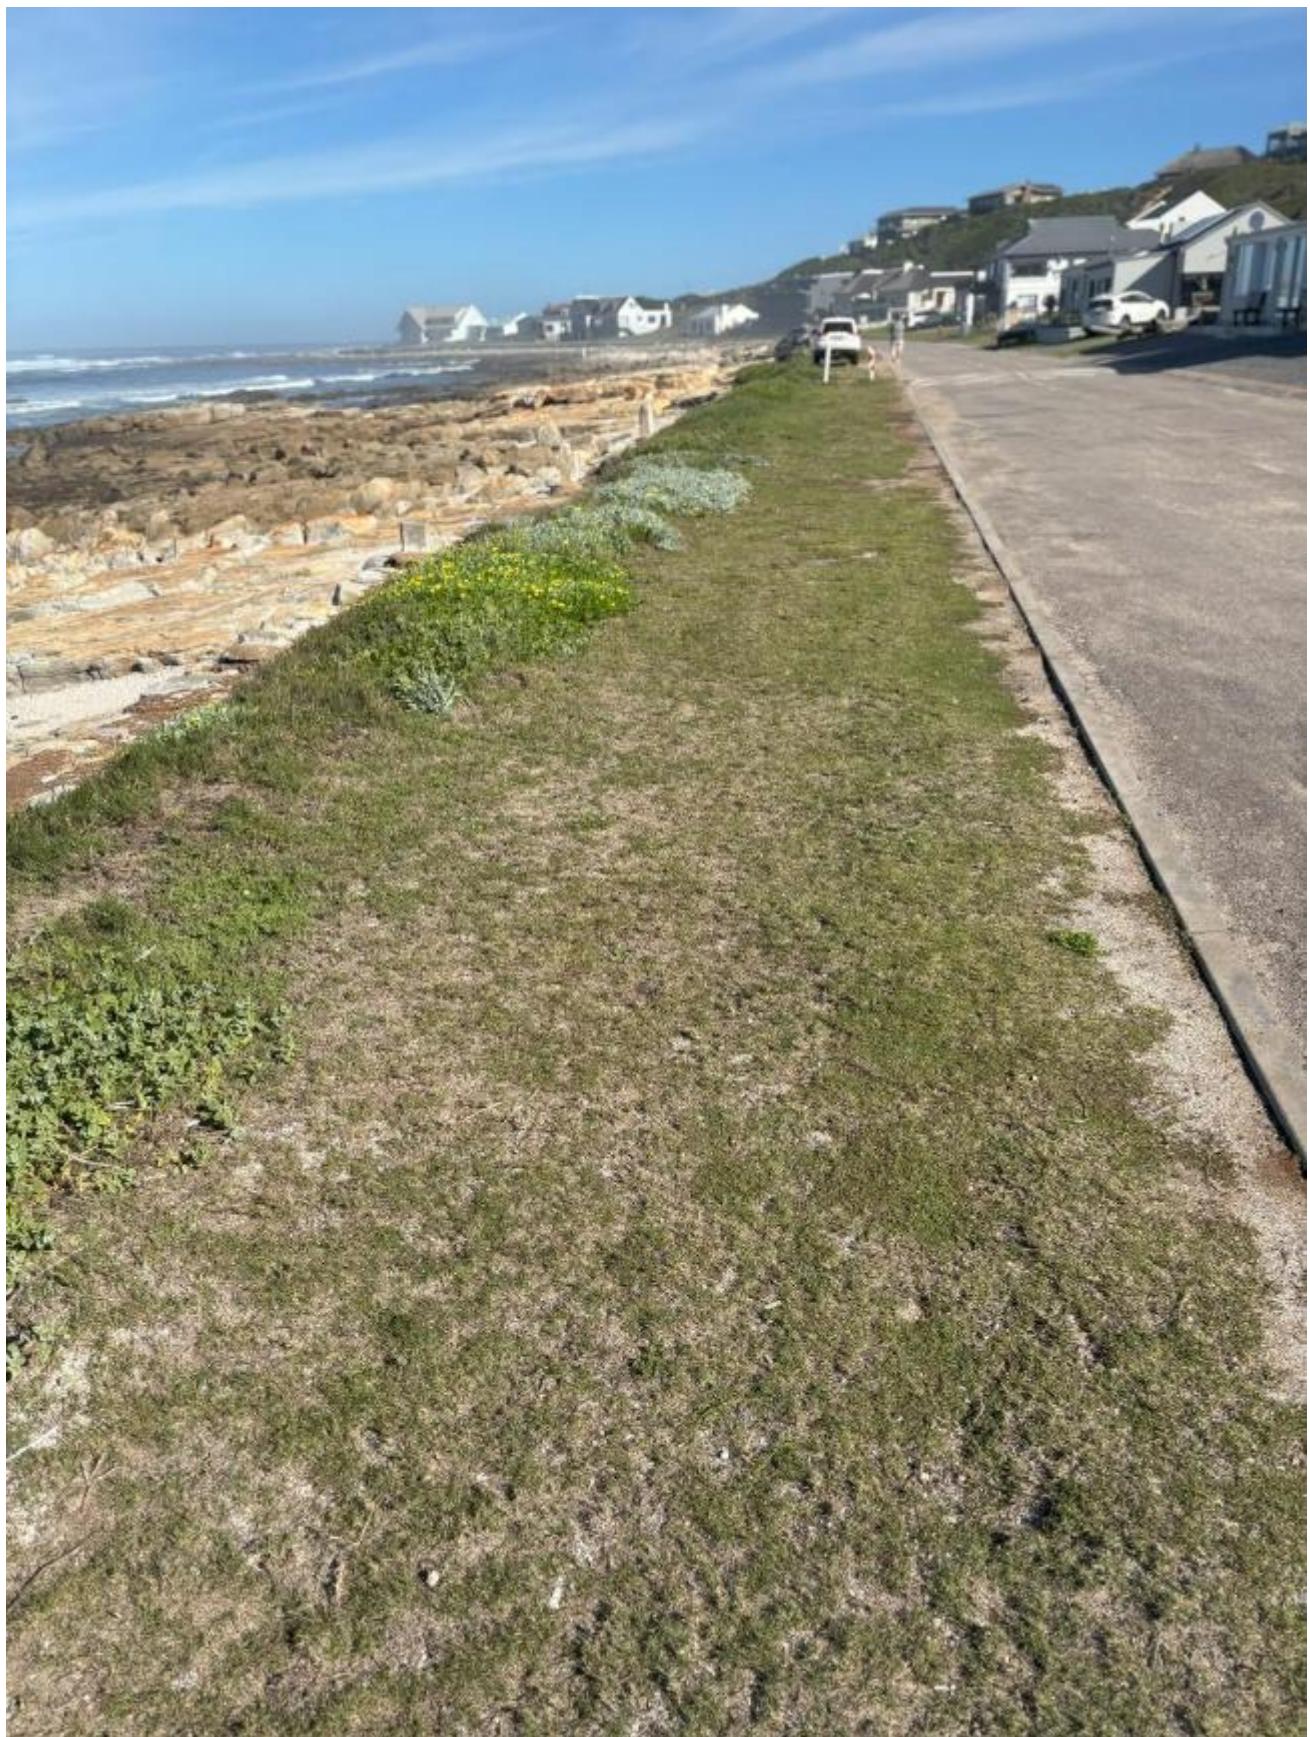
Figure 52 Vegetated roadway verge at Ch 350 looking southwards. Natural rock retaining wall on seaward side not visible

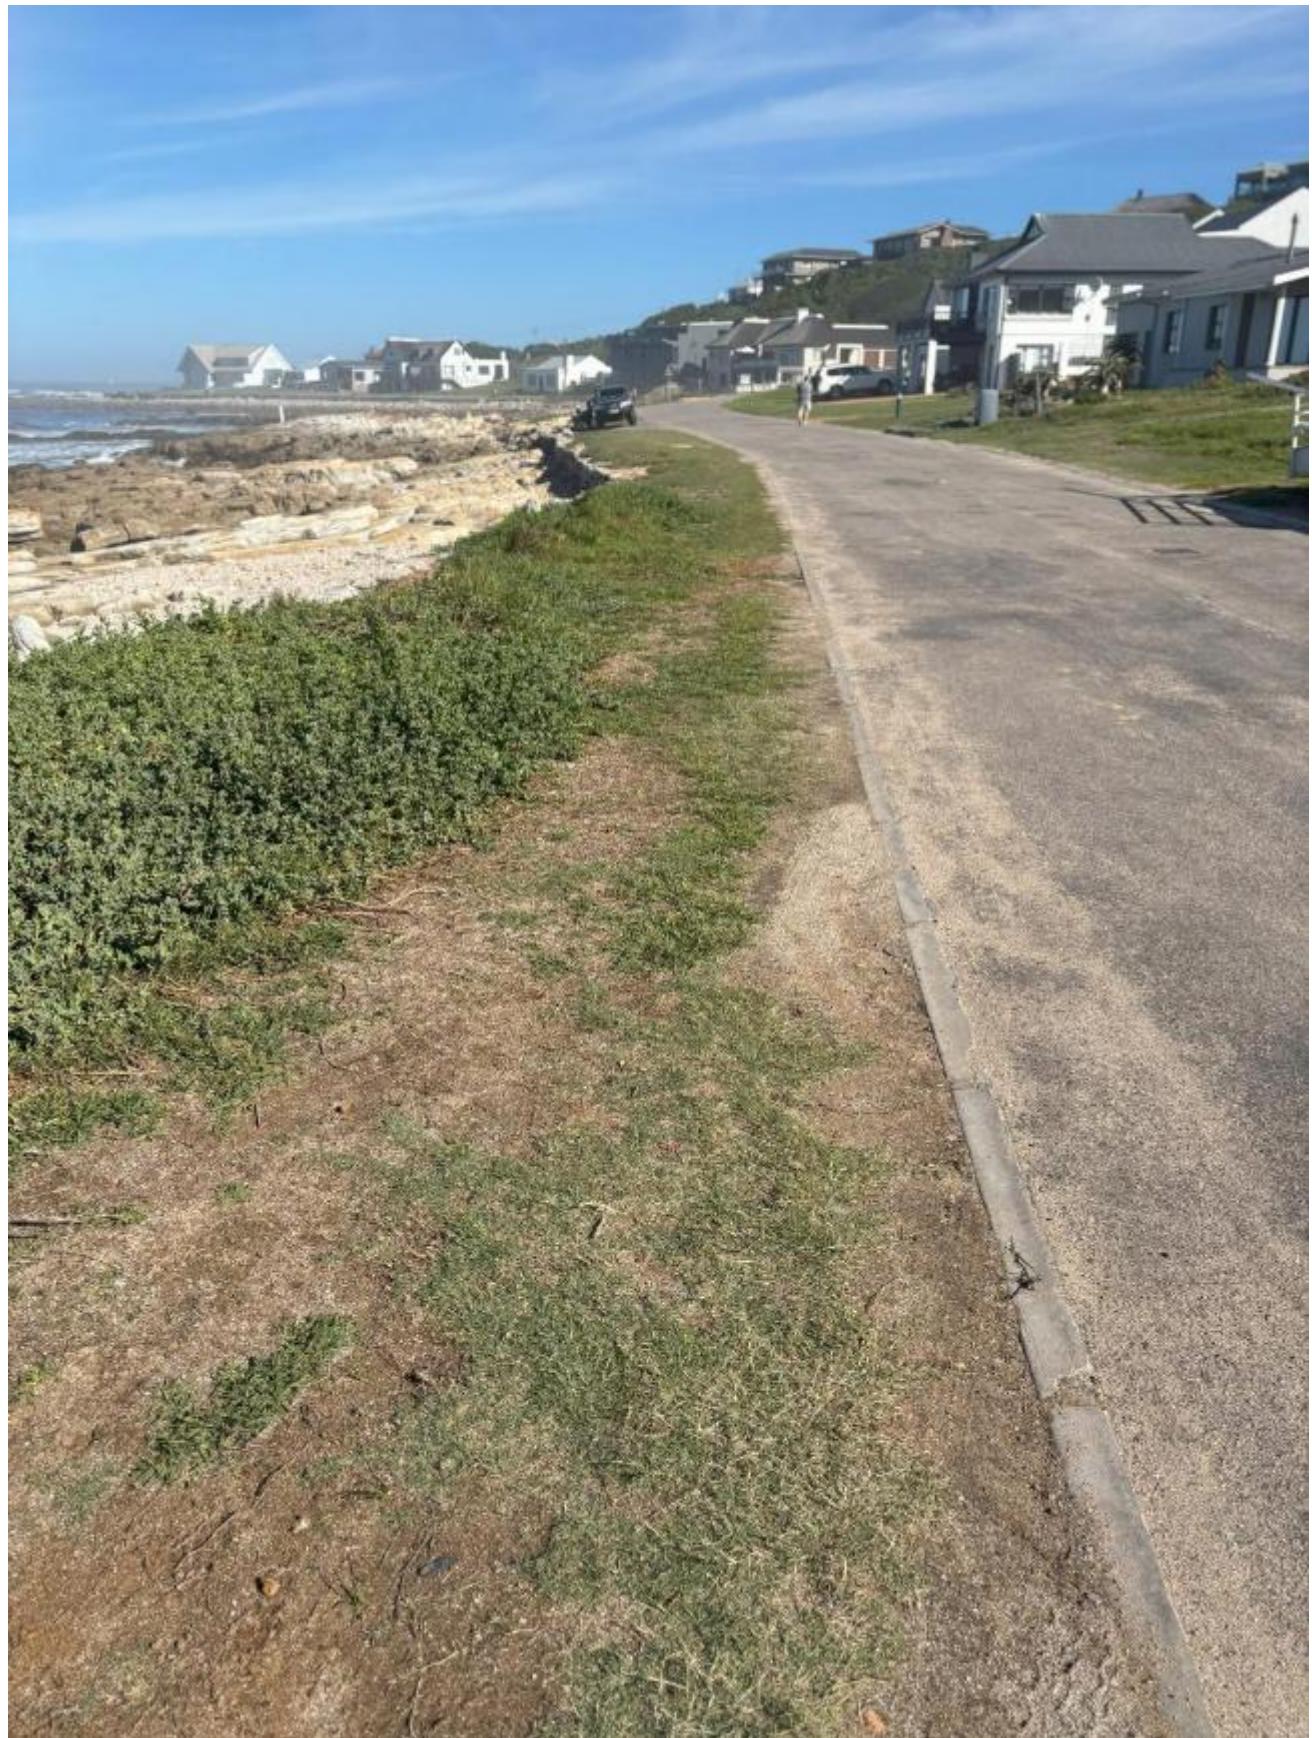
Figure 53 Vegetated roadway verge at Ch 400 looking southwards. Natural rock retaining wall on seaward side not visible

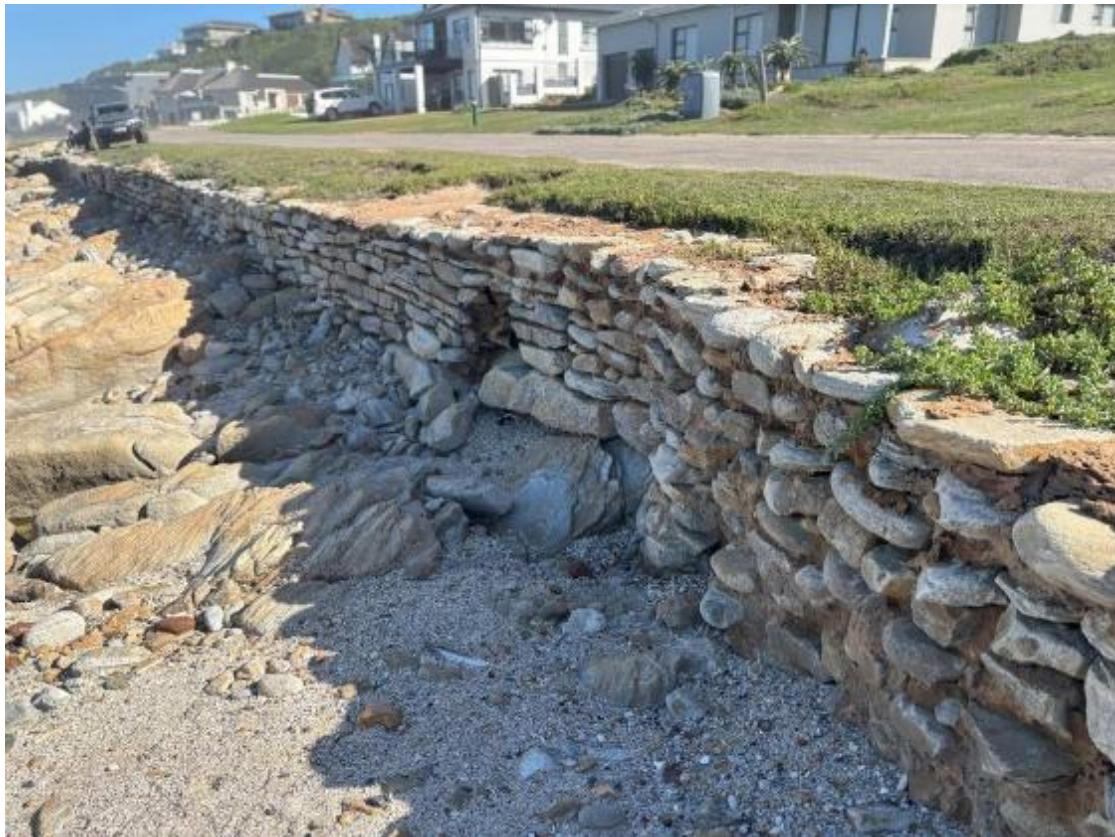
Figure 54 Vegetated roadway verge above natural rock masonry retaining wall around Ch450

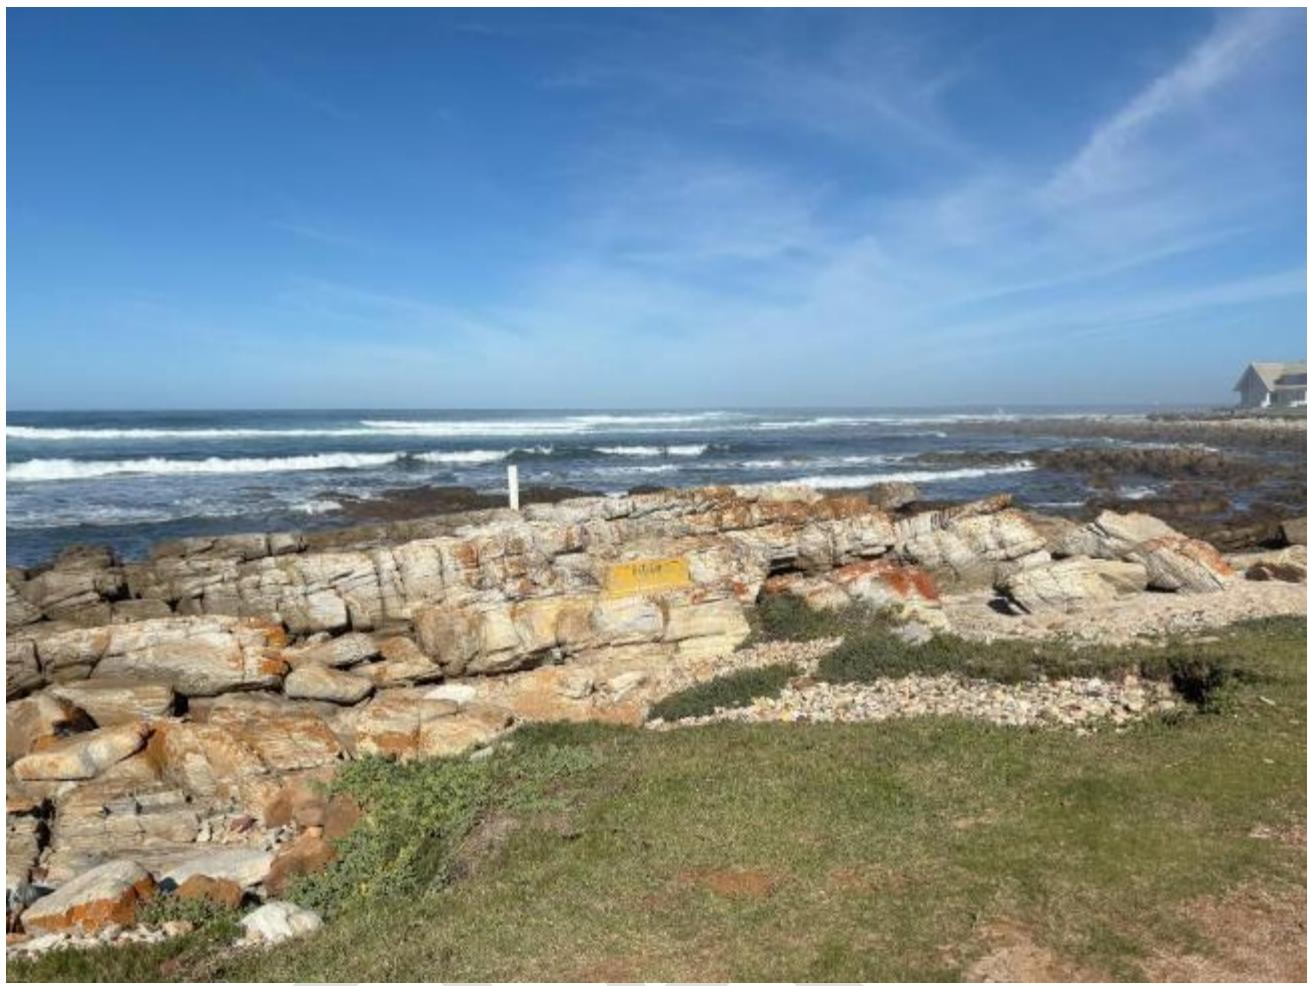
Figure 56 Vegetated area on road verge next to Paaltje Ch500

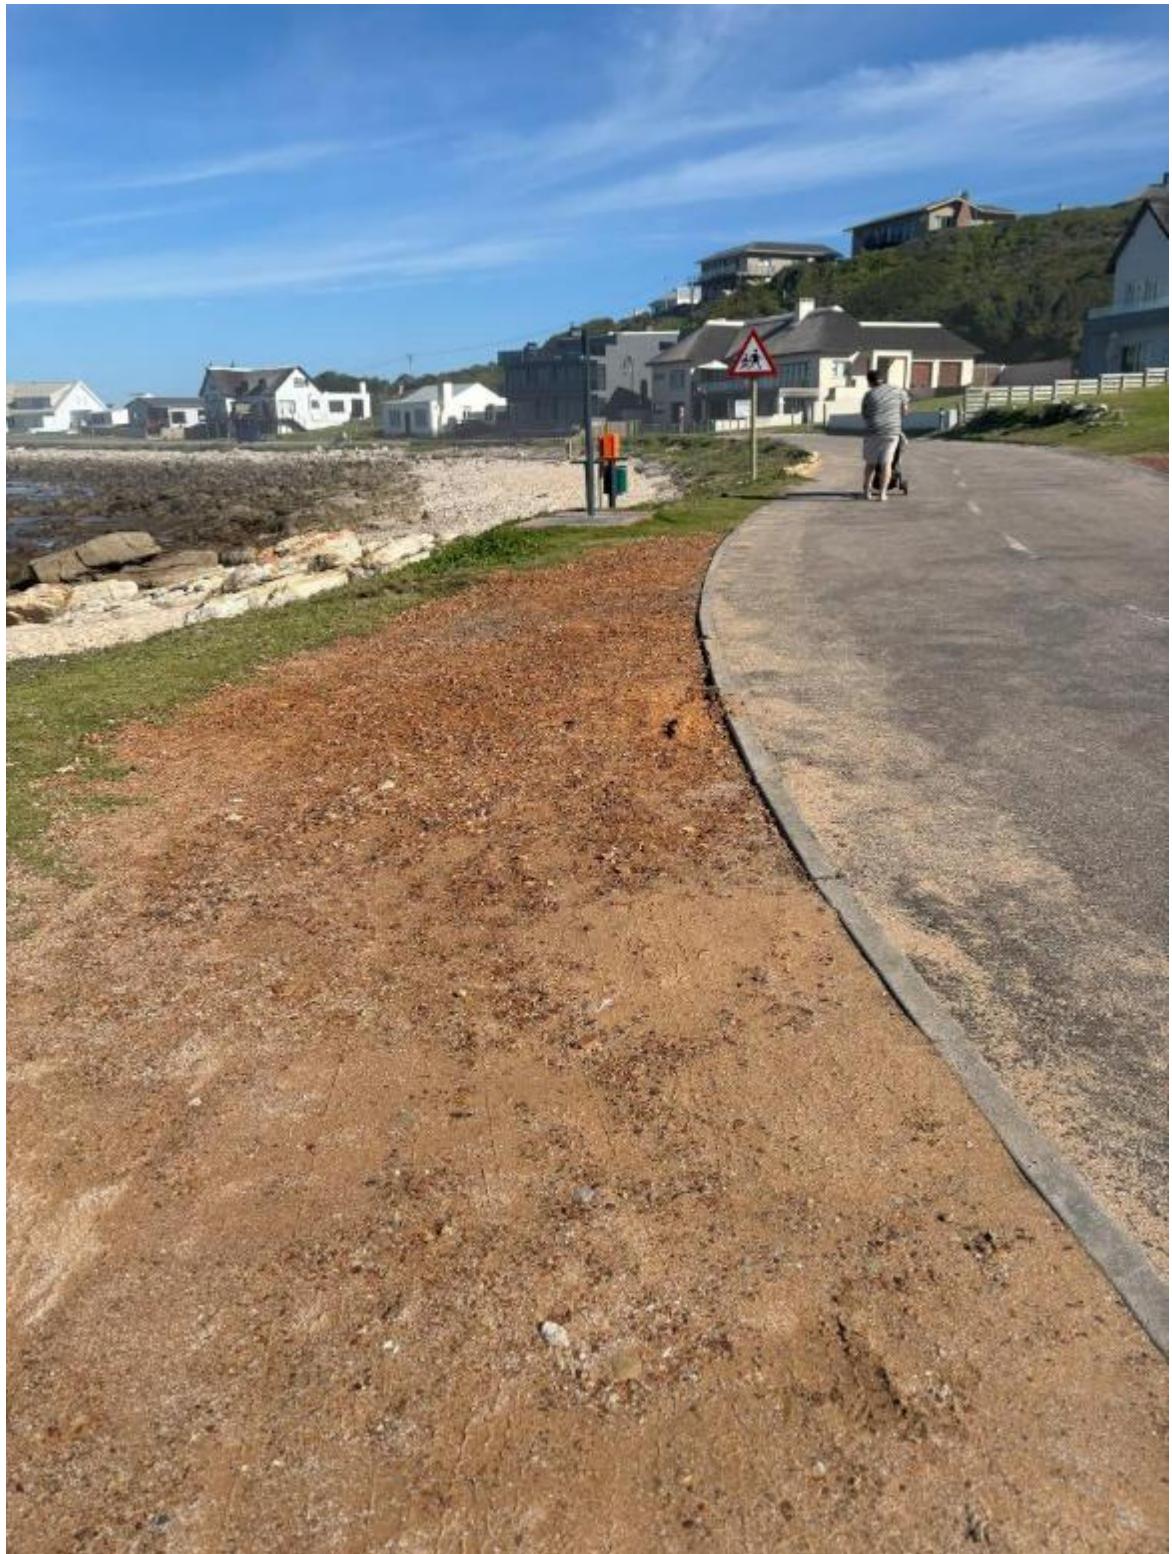
Figure 57 Gravel verge Ch500

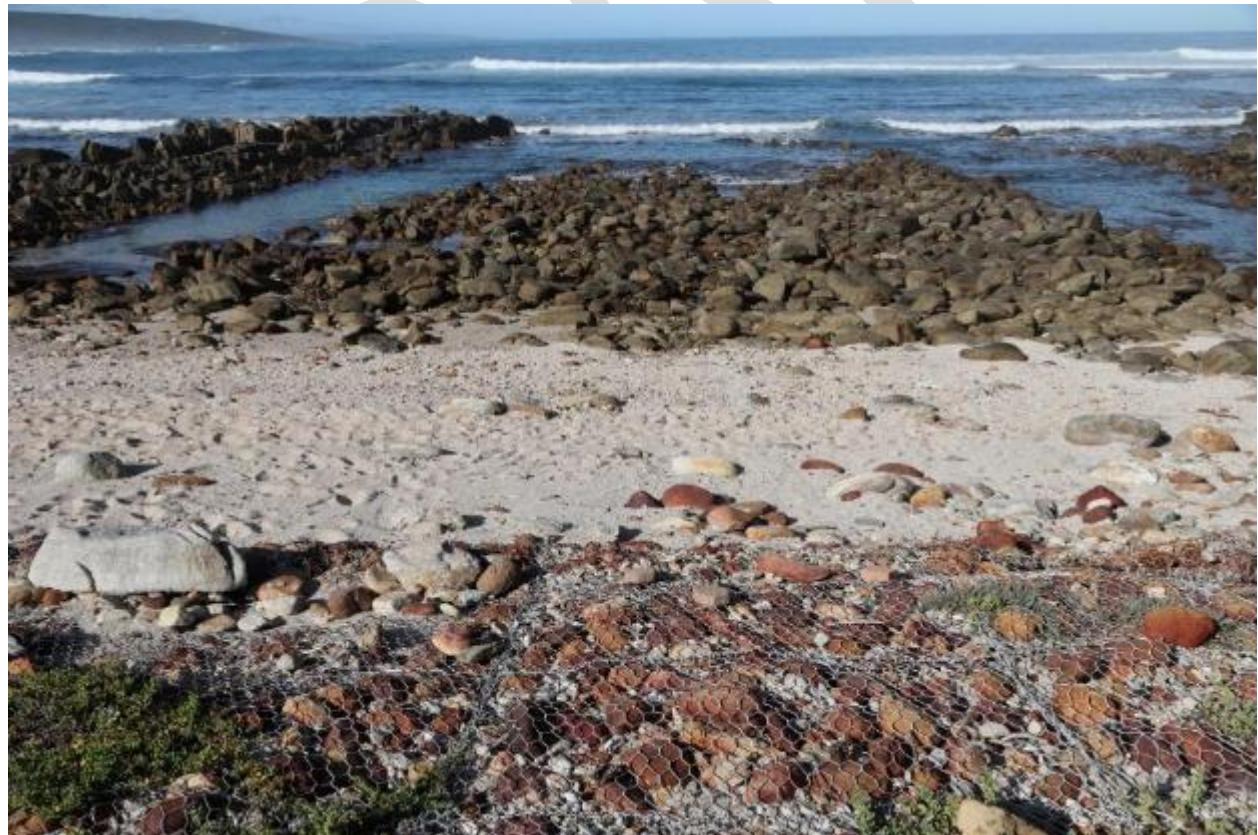
Figure 61 Seaward view Ch570 showing gabion mattress edge followed by sandy beach strip and rocky foreshore to ocean

The gabion mattresses are left in position, but where their condition has deteriorated, repairs are done to yield an aesthetically pleasing structure. A wooden pedestrian walkway is constructed all along Strand Street above the gabion mattress section. An indicative cross-section is provided below.

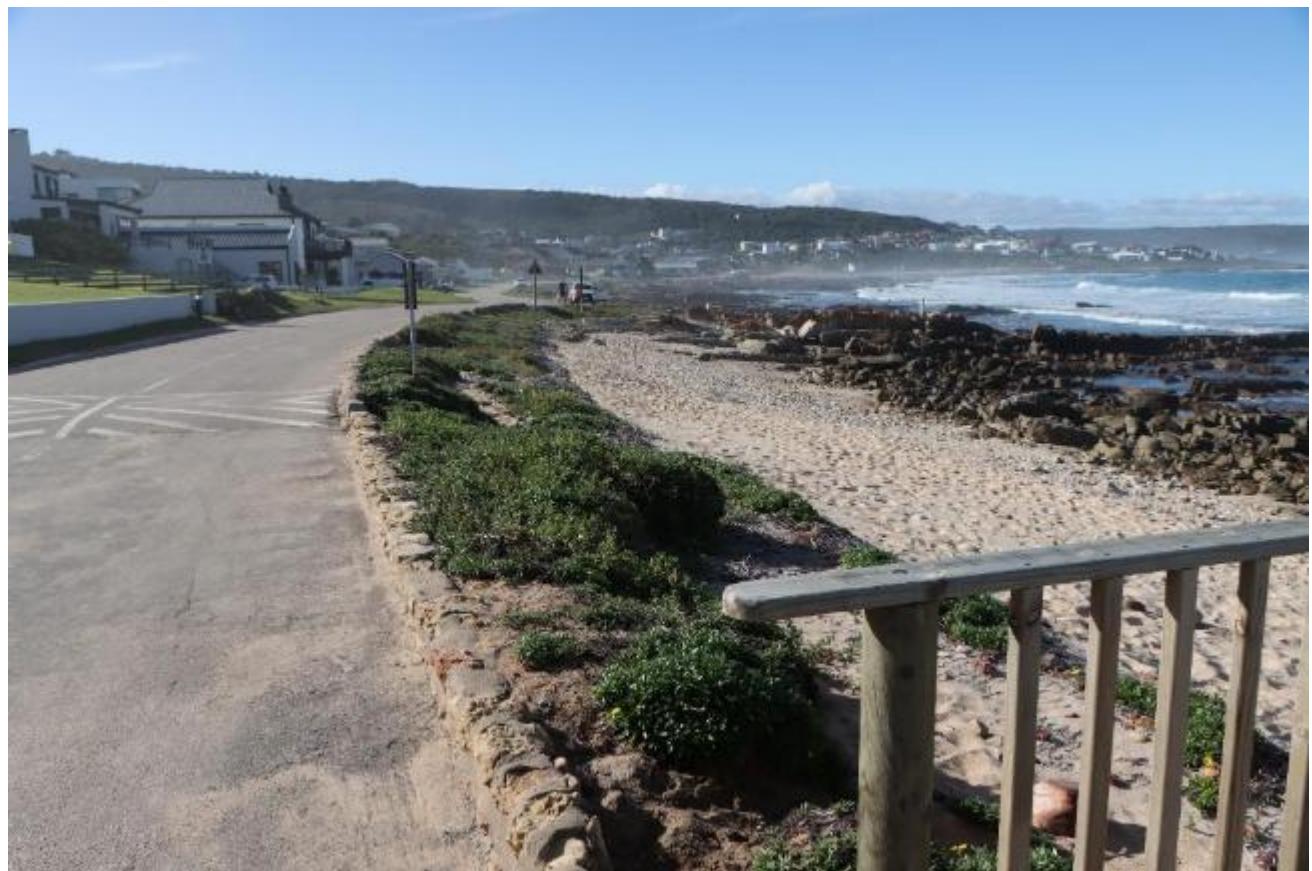
Figure 63 Northward view from Ch570 covering much of the extent of Jongensfontein Promenade
