# JONGENSFONTEIN PROMENADE

## Motivation and Preliminary Development Concept – DRAFT REPORT

This report provides an assessment of the vulnerability and risk associated with the Strand Street shoreline interface from a coastal engineering perspective, and makes recommendations of possible structural interventions to address flooding and associated risks.

This report was written by coastal engineering specialist Dr André van Tonder, B Eng, Hons B Eng, PhD (Civil Engineering), Pr Eng, for use by the Jongensfontein Ratepayers Association (JRA).

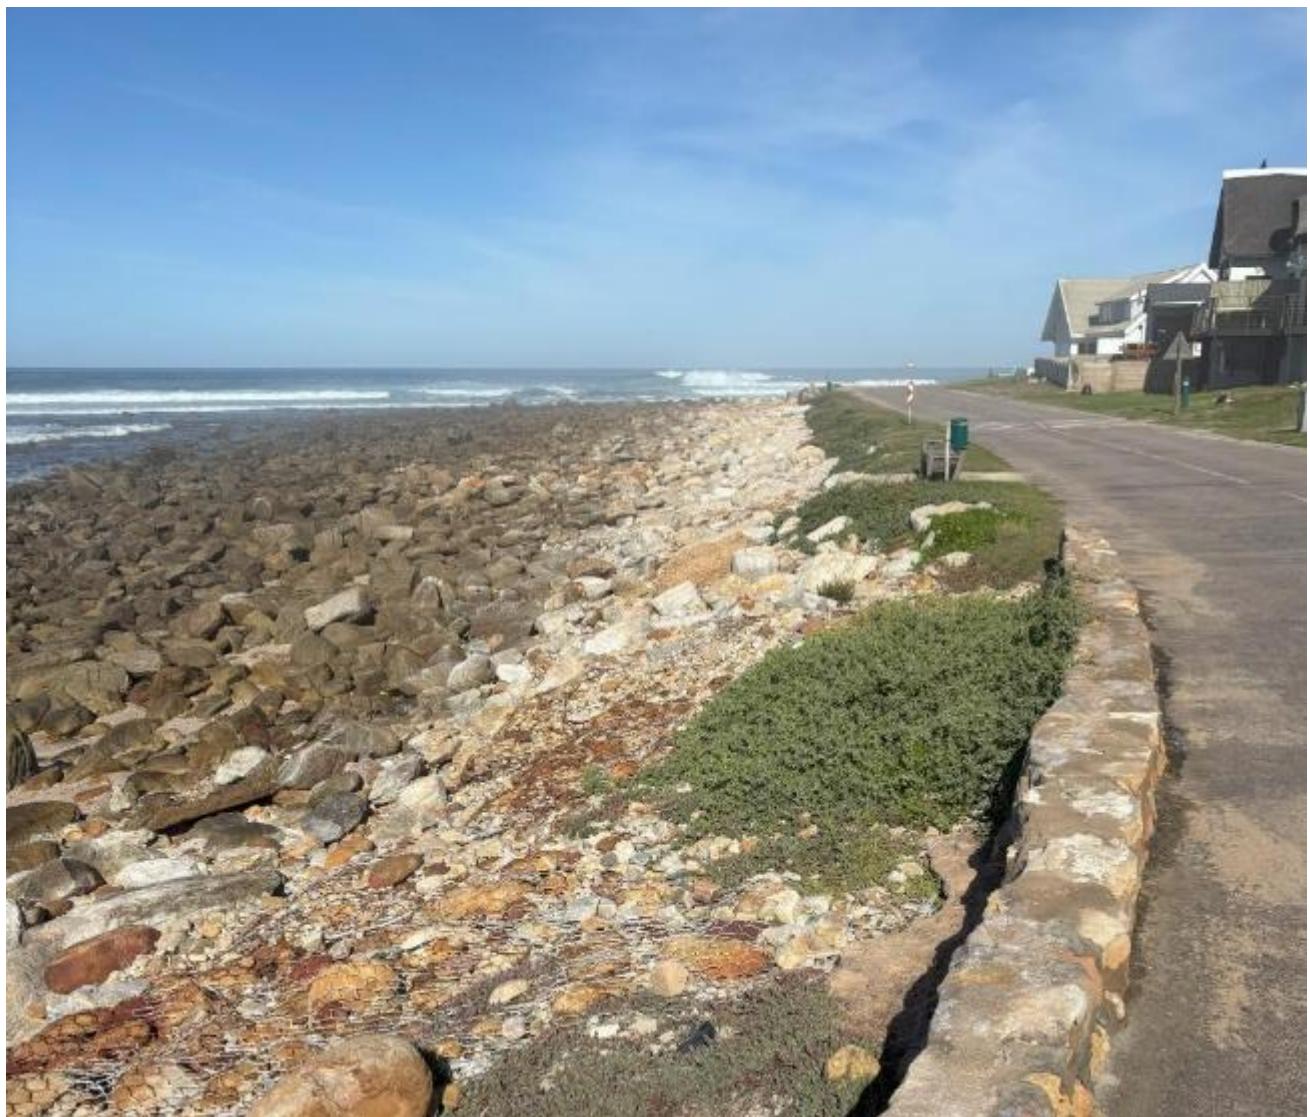
Figure 64 Southward view from Ch600: Gabion mattress verge coming to end and replaced by vegetated verge going south

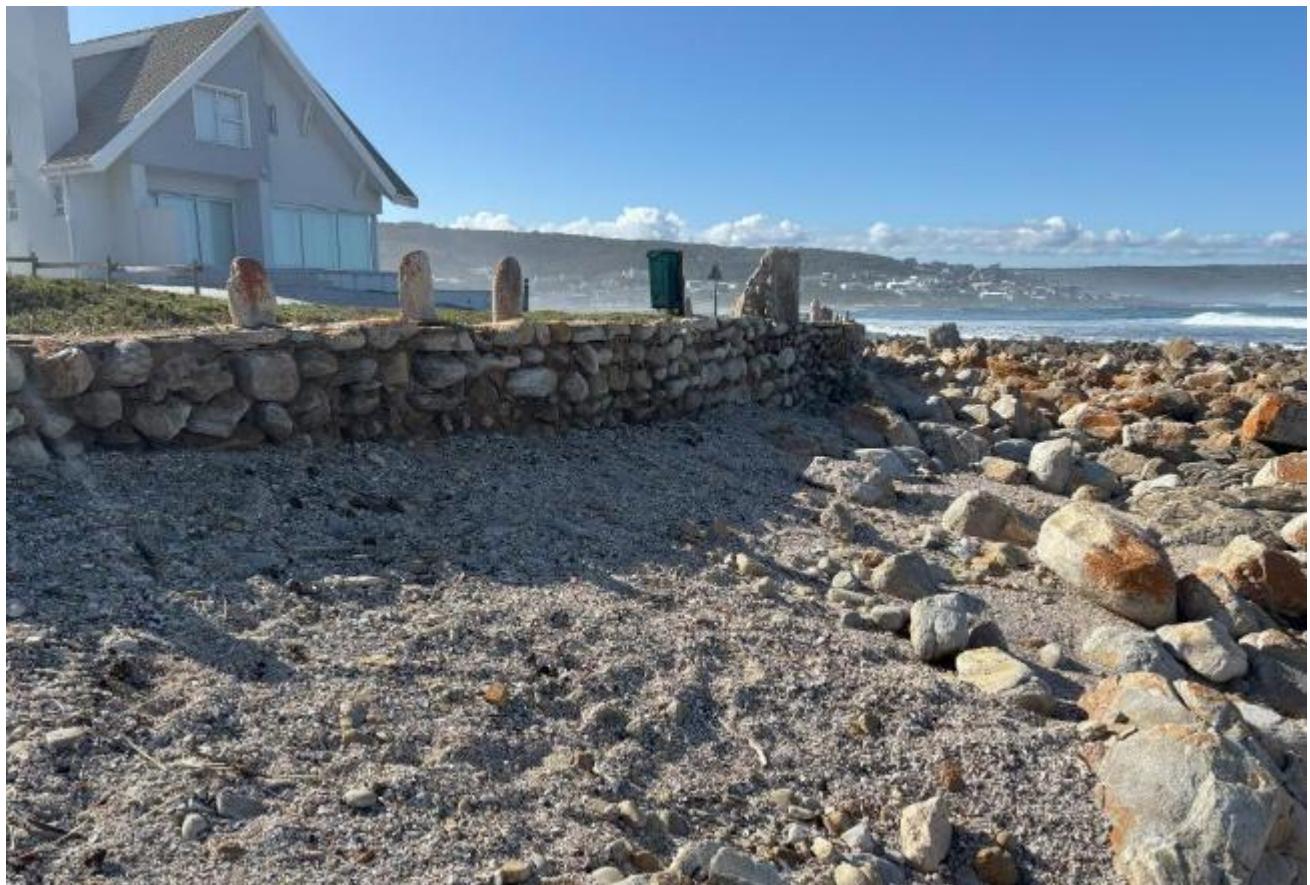
Figure 70 Natural rock retaining wall from seaward side at Ch780

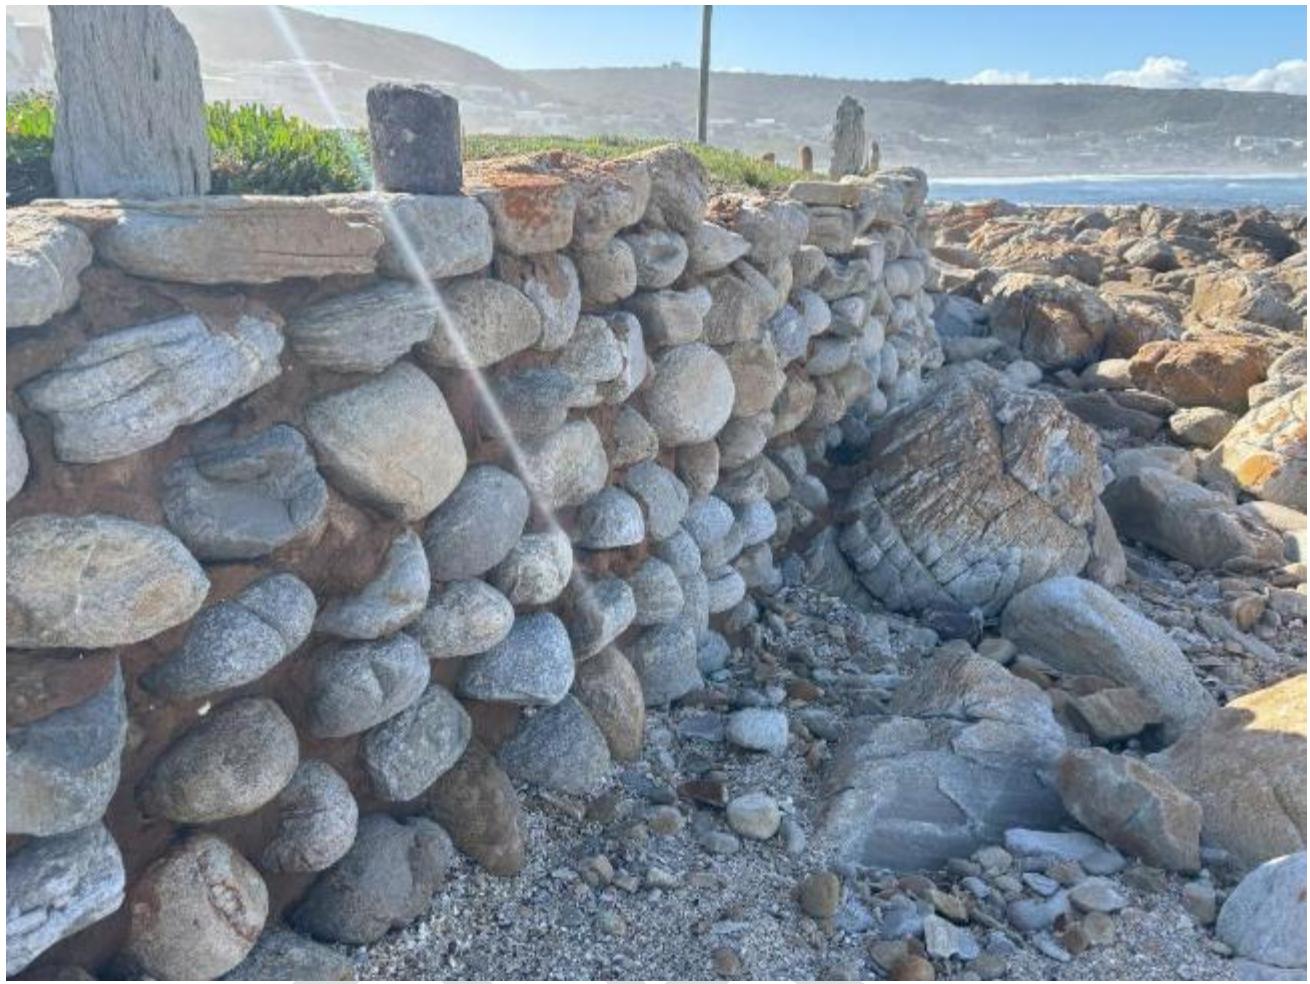
Figure 71 Natural rock retaining wall from seaward side at Ch750

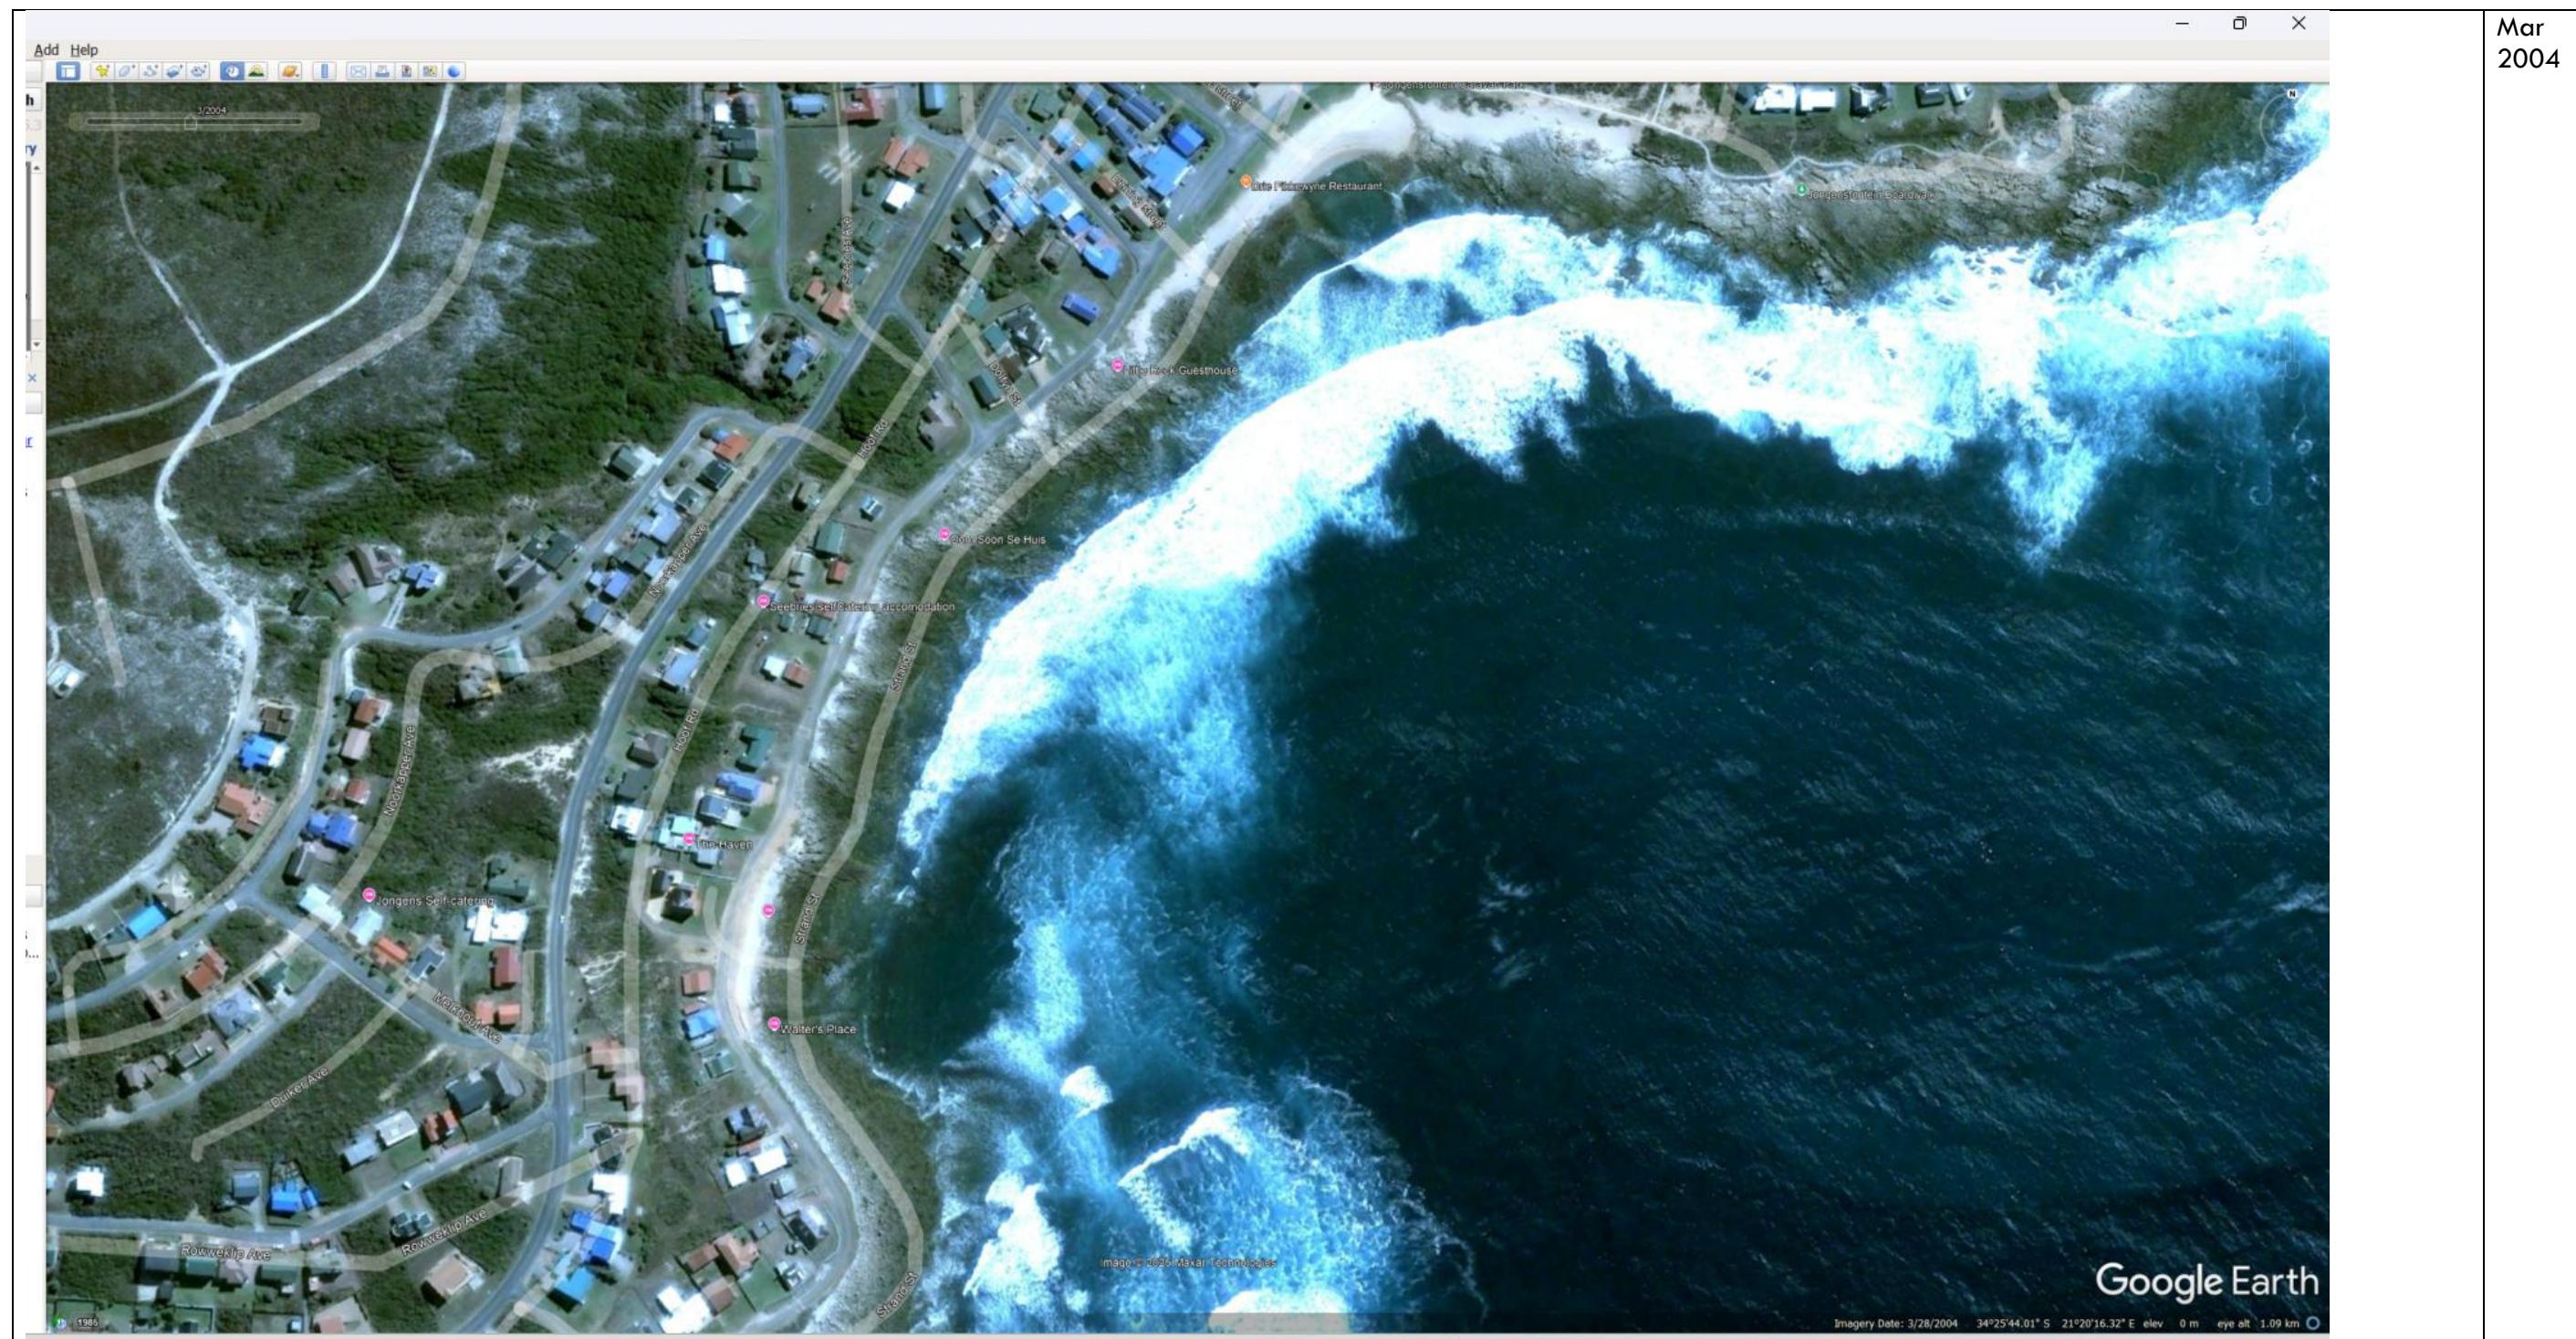
On the ocean side the differences in wave patterns are obvious, dependent on the prevailing wave conditions at the time the satellite image was taken. Also, images were taken at different tidal levels, hence there is difference in the water line from image to image. Differences in the sizes of sandy beach areas, if they do occur, are of such a limited extent that no particular trends are evident.

Overall, the images indicate a stable nearshore and coastal domain.
